LOS ANGELES FIRE DEPARTMENT

SUBJECT: BOYD STREET INCIDENT REPORT

Los Angeles City Fire Department Informational Summary Report

**May 16, 2020
Boyd Incident
CA-LFD-001073**

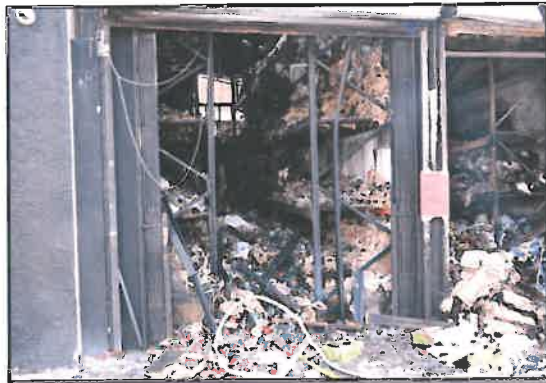
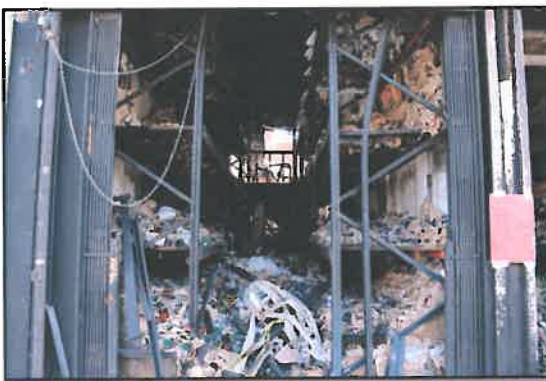
Alpha side looking into Unit A

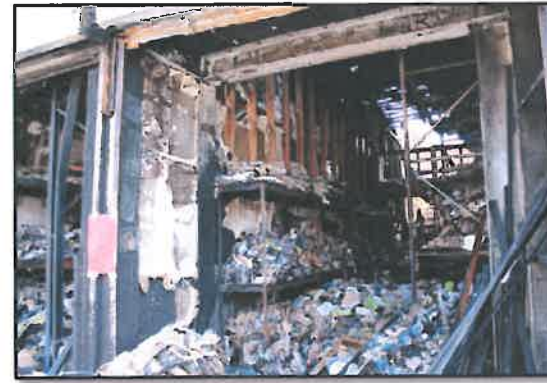
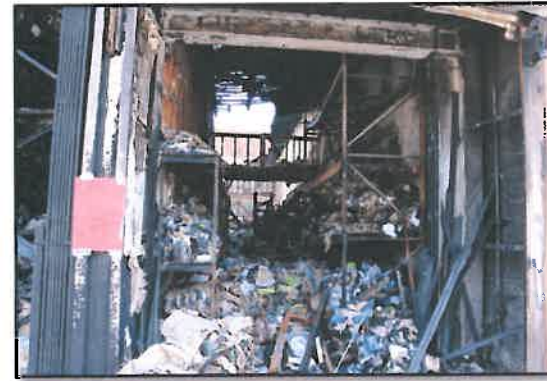
Alpha side looking into Unit B

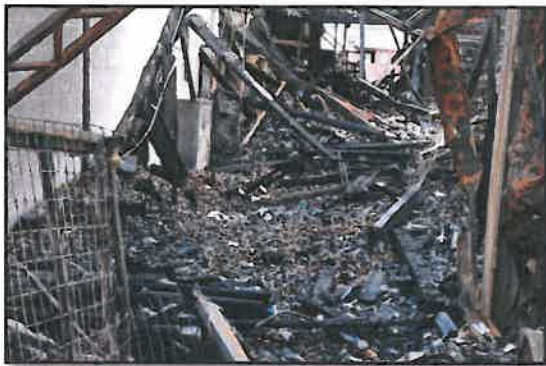
Charlie side looking into Unit B

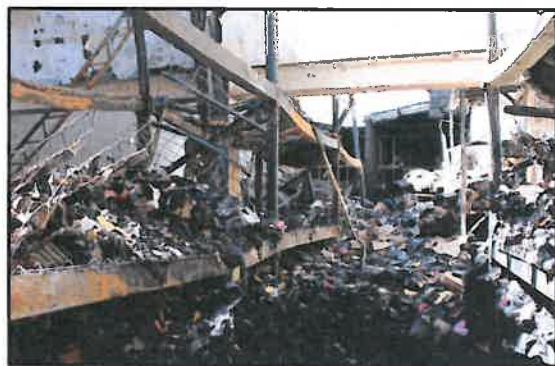
Charlie side looking into Unit A

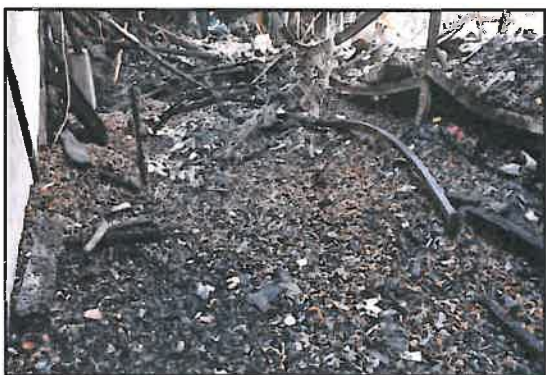
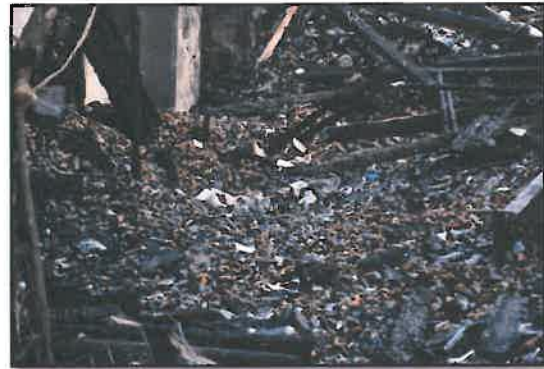
The small N_2O cylinders found on scene of the Boyd incident contained approximately 8 grams each of net product and have been known to release their contents in temperatures as low as 106 degrees Fahrenheit. As the fire intensity and pre-heating increased, the release of the N_2O increased. The temperature around the N_2O storage was approximately 400 – 900+ degrees Fahrenheit early into the event.

According to industry experts, when large quantities of product contained in the cylinders are stacked in quantity and exposed to heat, they can release or explode from the outer edges of the storage configuration, working inward until a critical temperature is reached. This can cause a simultaneous release of a large portion of the product to occur with violent results.

Spent Nitrous Oxide Chargers in Unit B

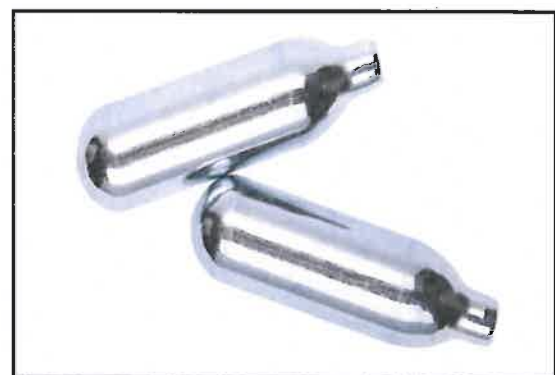
Nitrous Oxide Chargers 8oz.

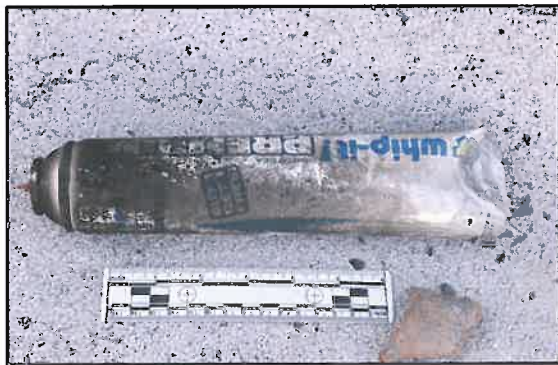
Butane Canisters

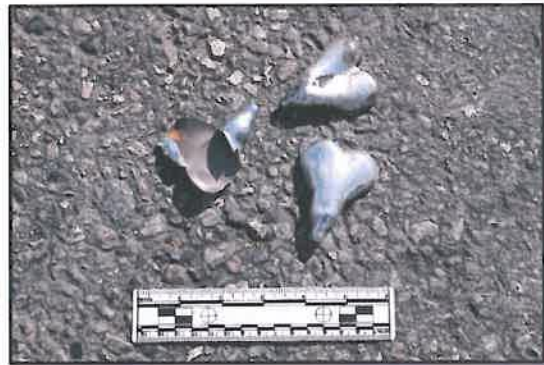
Spent Nitrous Oxide Chargers

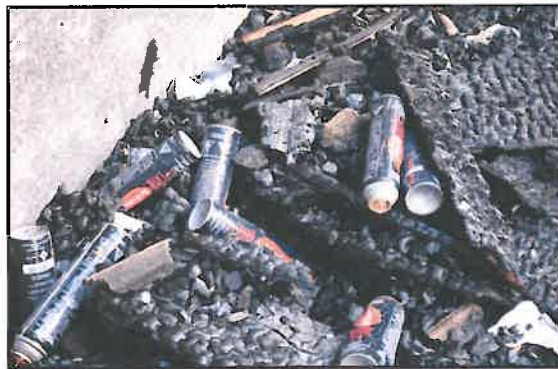
Butane Canisters in Unit B

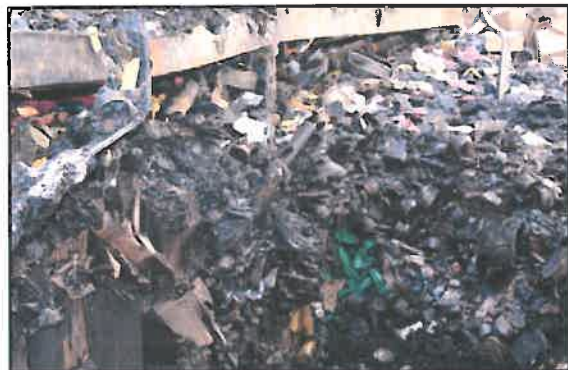
Contents in Unit A

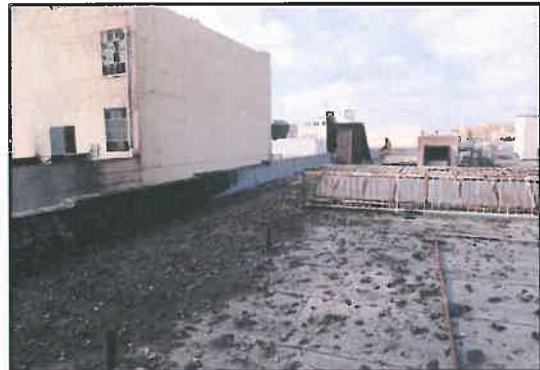
Nitrous Oxide Chargers on Bravo exposure roof

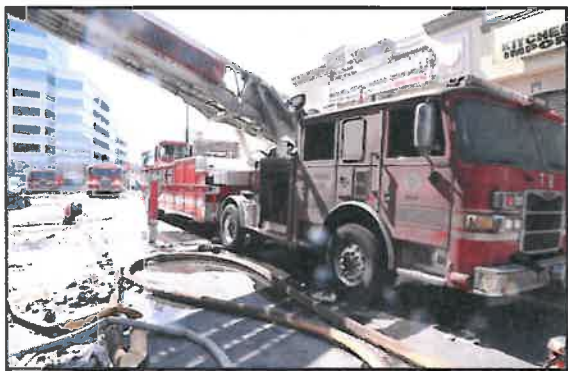
Aerial Ladder Truck Tractor and Trailer damage

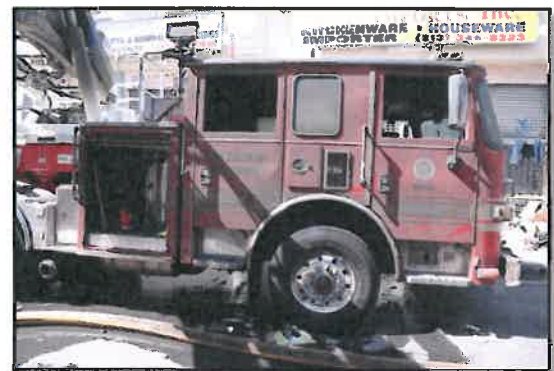
Aerial Ladder Truck Exterior Cab damage

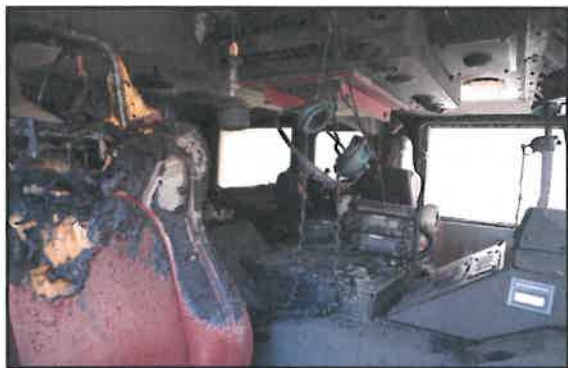
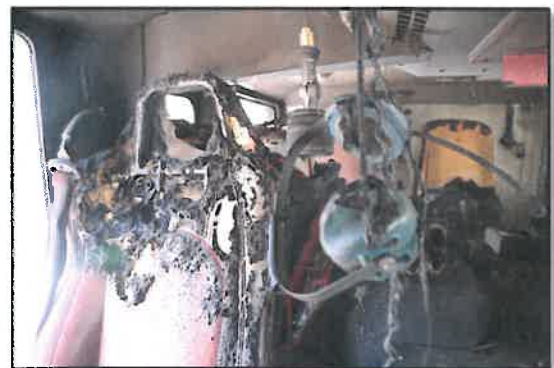
Aerial Ladder Truck Interior Cab damage

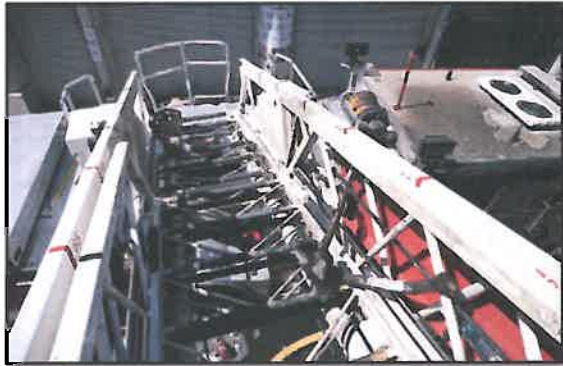
Aerial Ladder and Equipment damage

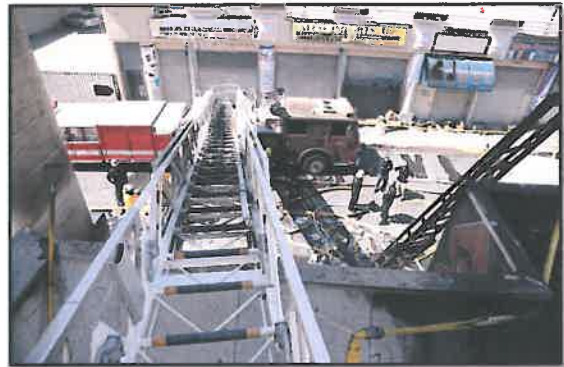
Aerial Ladder damage

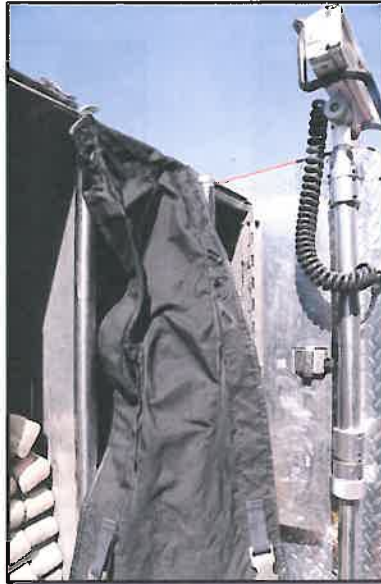
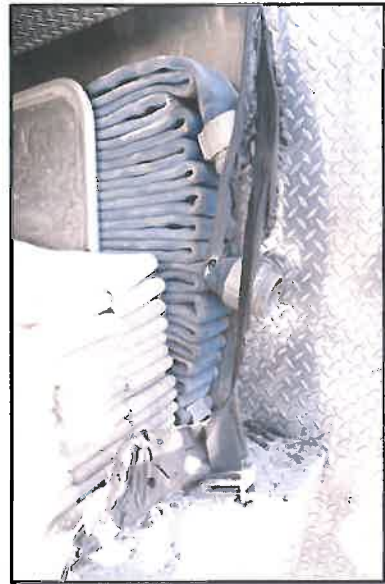
Engine hose cover damage

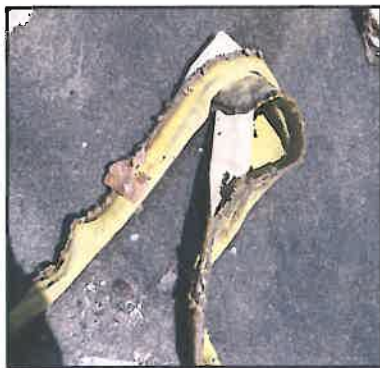
1 3/4" hose line damage

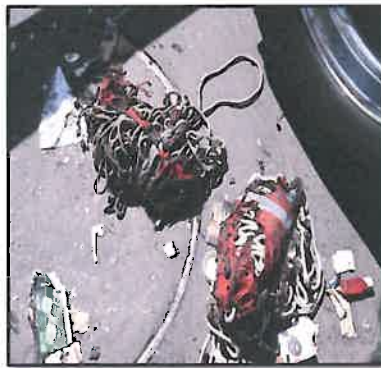
Drop bag damage

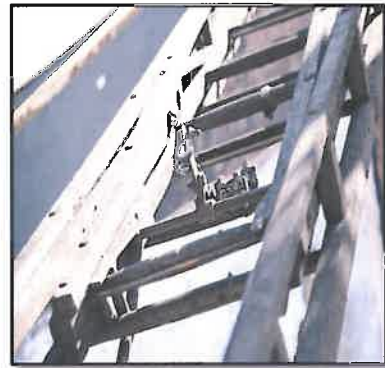
35' Extension Ladder damage
