SUPPLEMENTAL HISTORIC STRUCTURE REPORT

HOLLYHOCK HOUSE

HOLLYHOCK HOUSE
CITY OF LOS ANGELES
LOS ANGELES COUNTY, CALIFORNIA

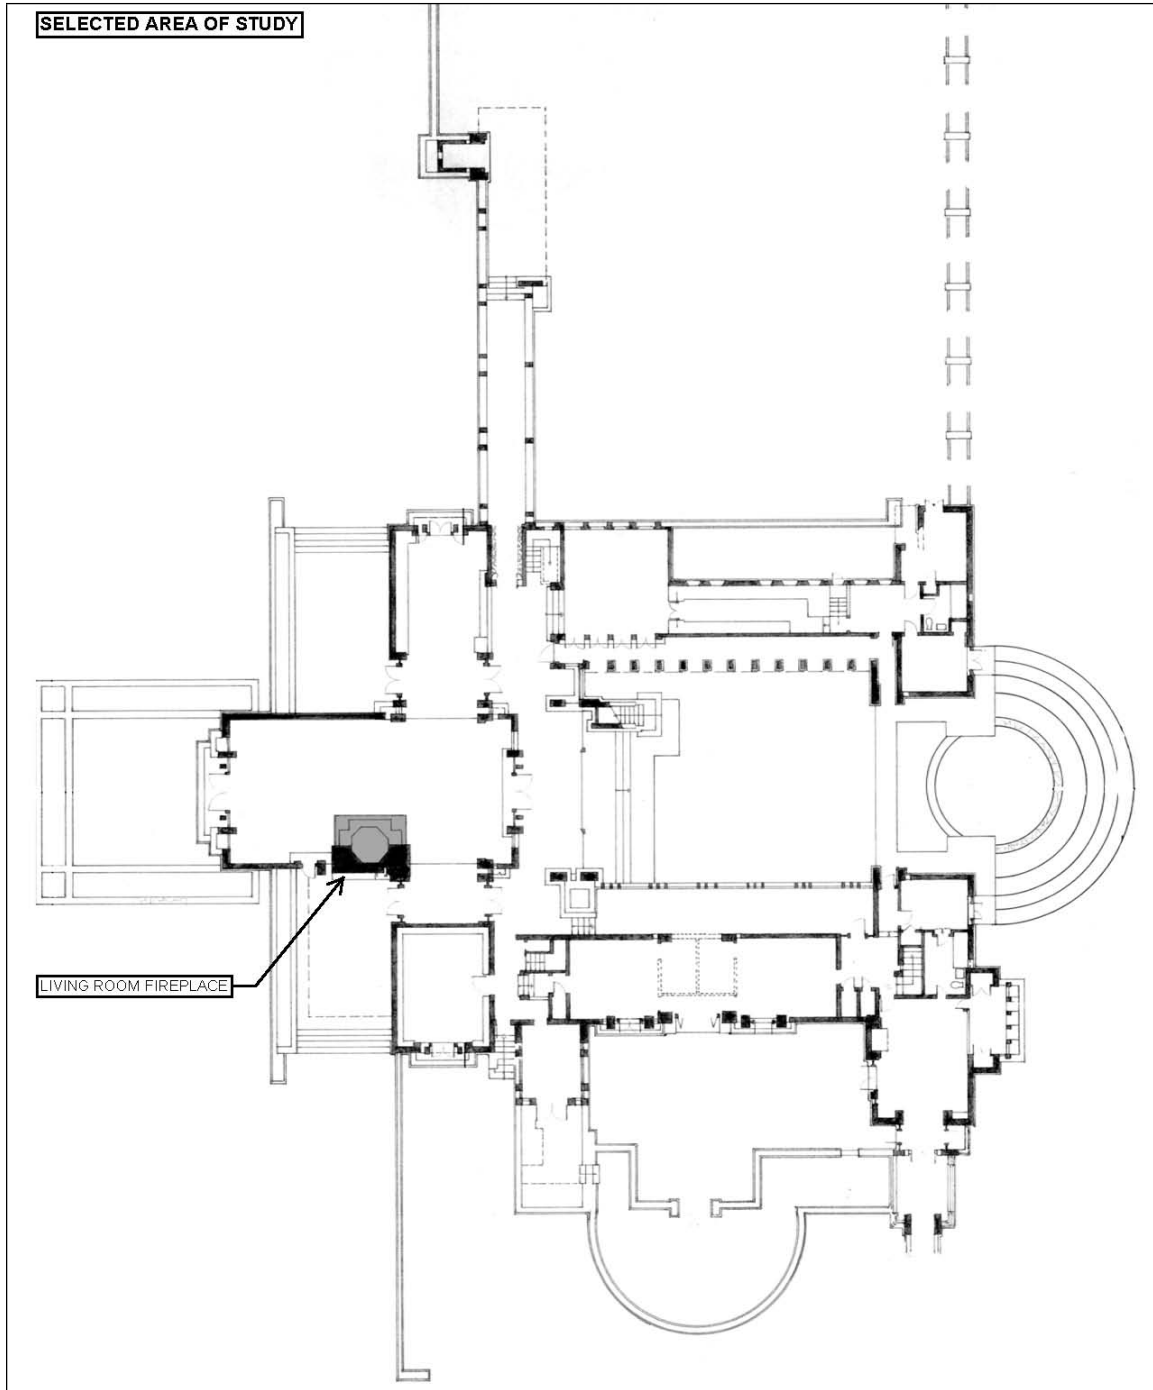
Figure 10: Area of Study 1: Living Room Fireplace.

If the decision is made to perform the work without removing existing decorative material, it should be noted that the likelihood of successfully shifting stones to counter the differential movement in the face is minimal. The risk of damaging the historic veneer by applying pressure to an edge or side is significant and would have to be carefully considered before proceeding.

Description of Options to Address the Issues. The subconsultants made the following recommendations as summarized below and described in greater detail in Appendices D, F, and H.

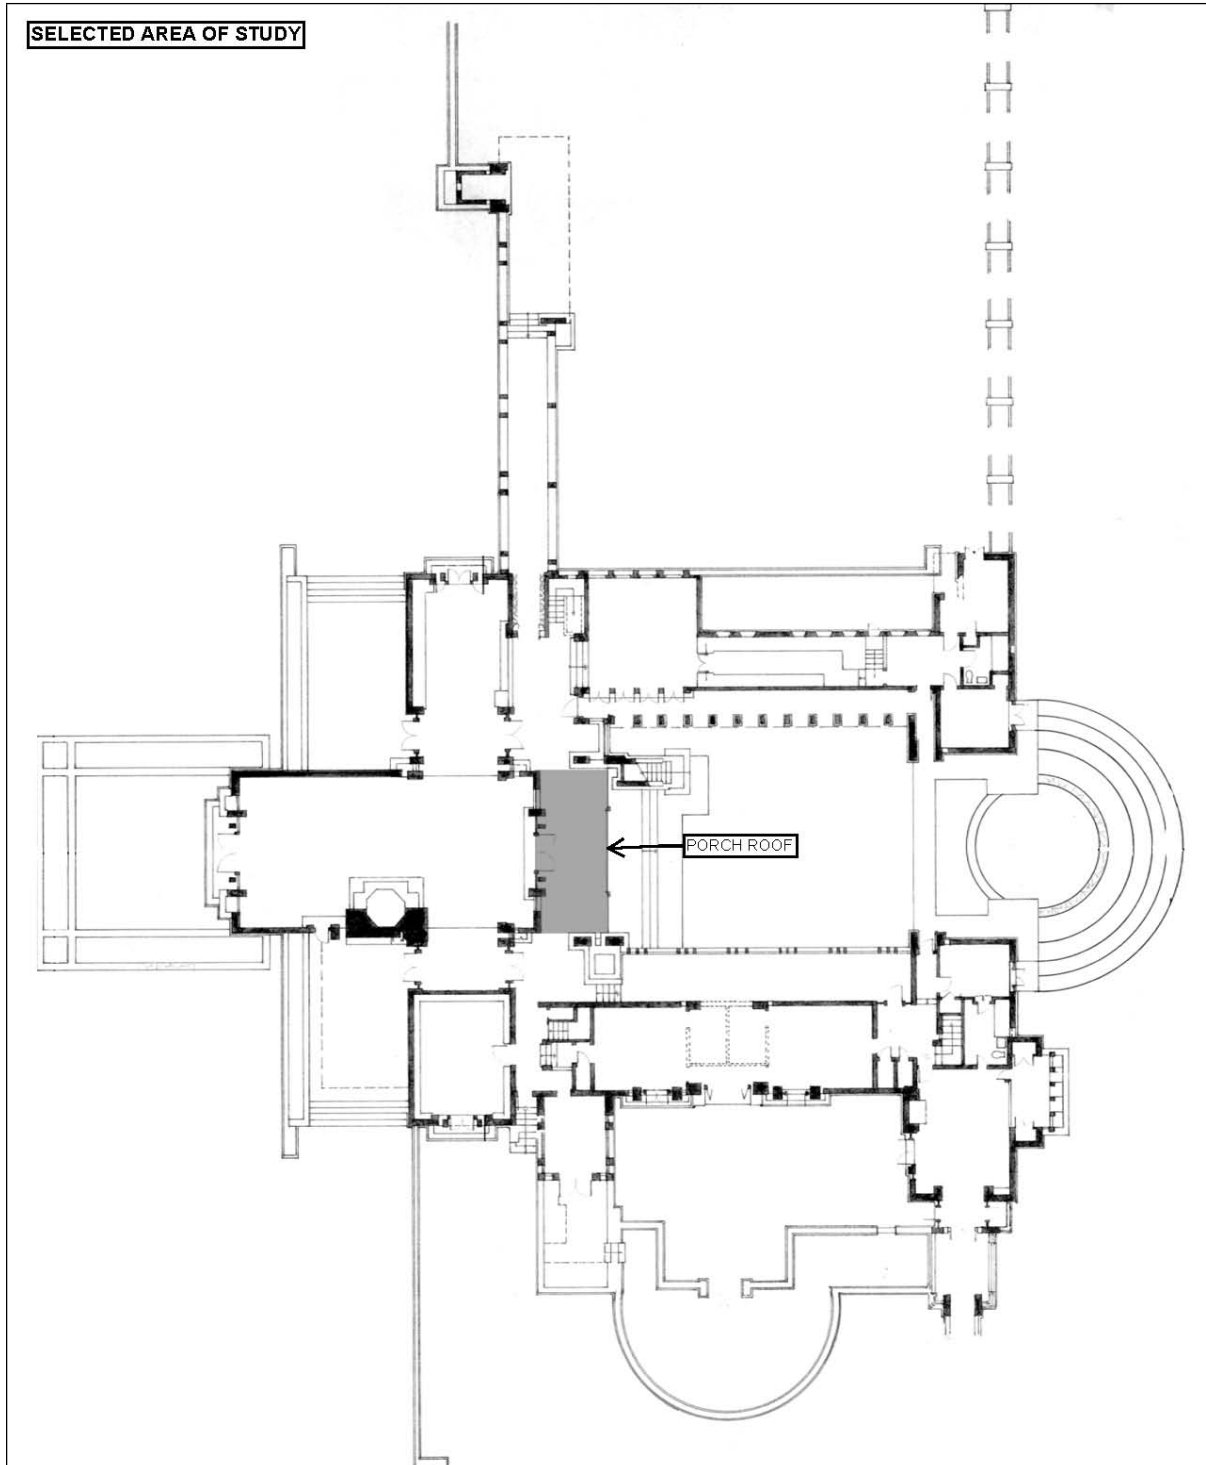
Figure 12: Area of Study 3: Porch Roof.

Moreover, while the tile roof surface is intended to accommodate pedestrian traffic, only occasional foot traffic should be permitted on the roof in the future. Calculations indicate that the total allocable dead plus live load is 41 pounds per square foot (psf). The dead load is 30 psf leaving about 11 psf for live load. The minimum roof live load is 20 psf. Public use of the porch roof would require a 100 psf live load, for which the porch roof is not designed.

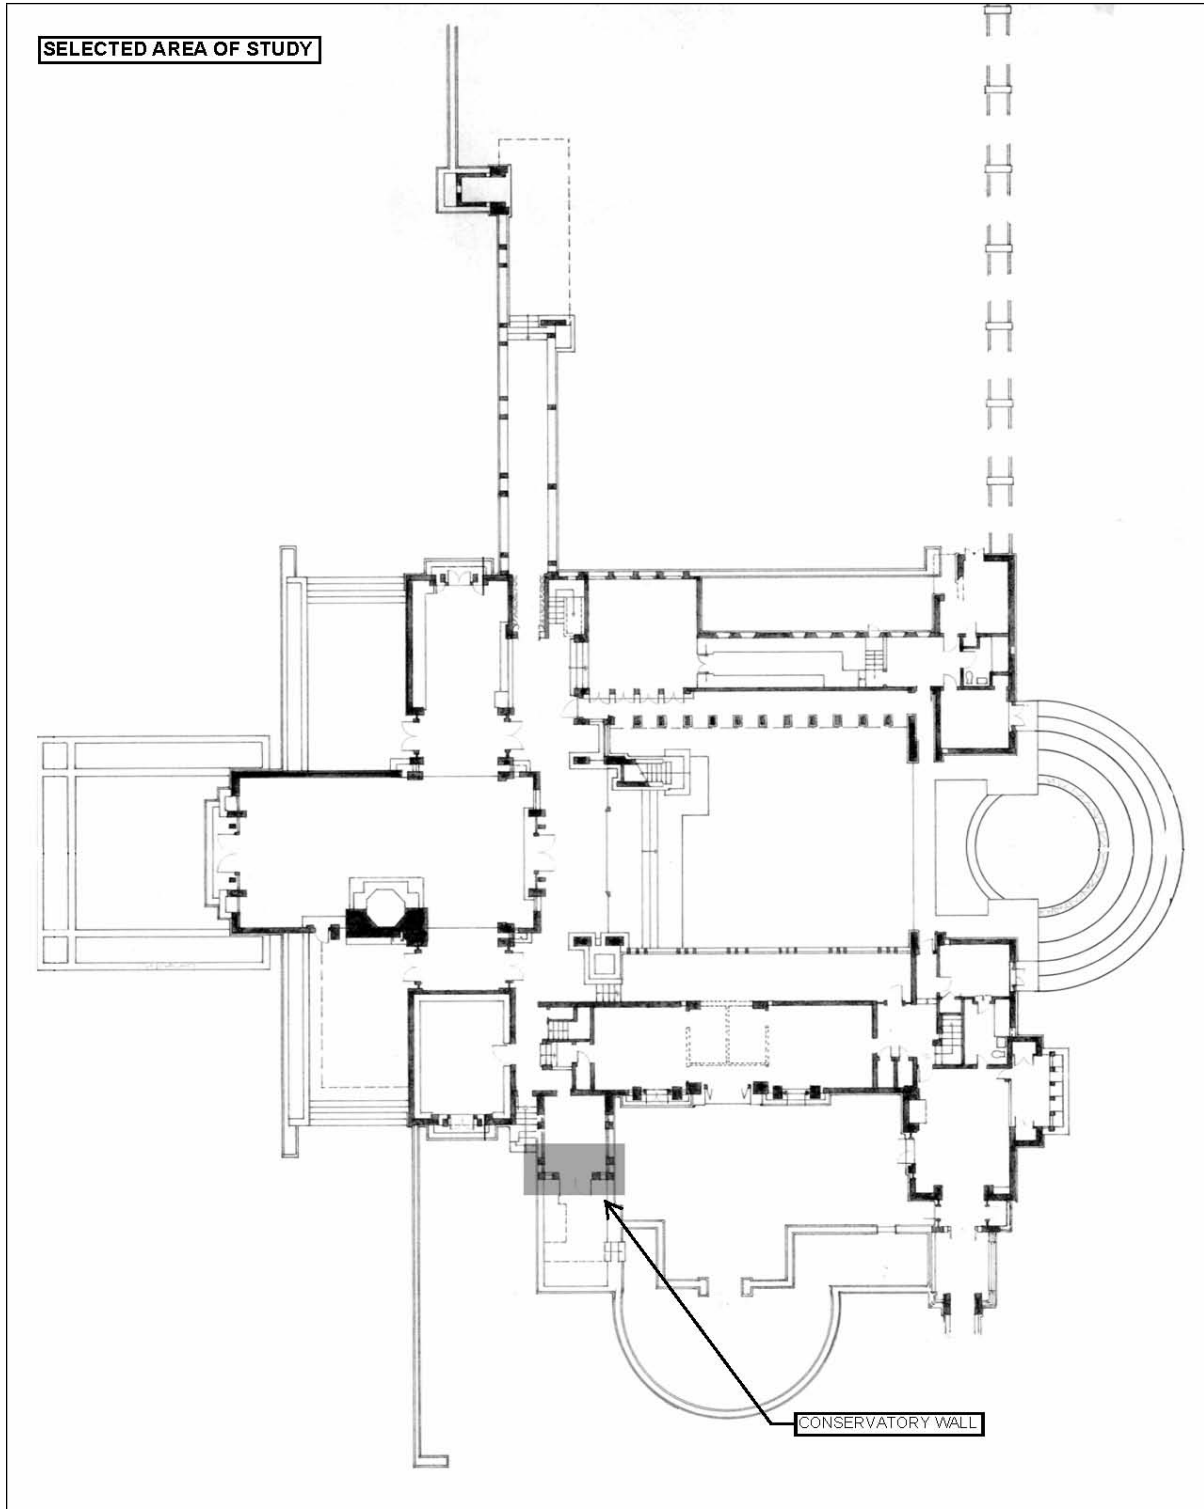
Figure 16: Area of Study 7: Conservatory.

Description of Options to Address the Issues. Cracks usually occur between different materials. In this case, the main factor is differential settlement between the two sections of foundation. (Why this occurs on the east wall and not the west is unknown.) A second factor is that the earthquake likely caused some widening of the crack.
