Conservation Report

PROJECT TITLE: Conservation Assessment of Interior Decorative Painted Features of Los Angeles City Hall

SUBJECT: Final Report

DATE: 6/6/2010

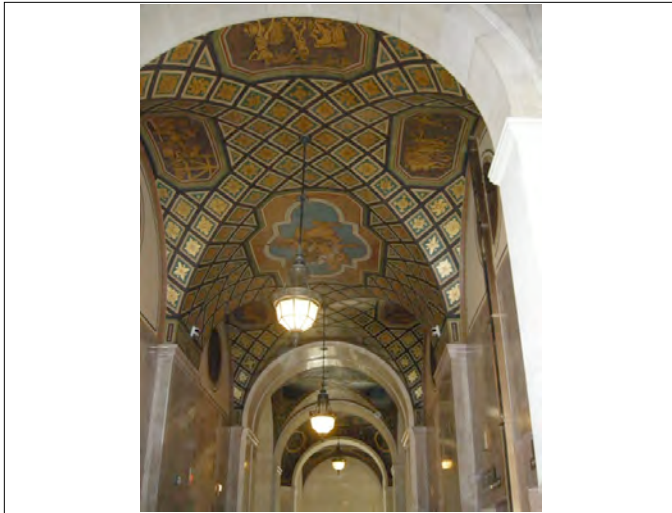
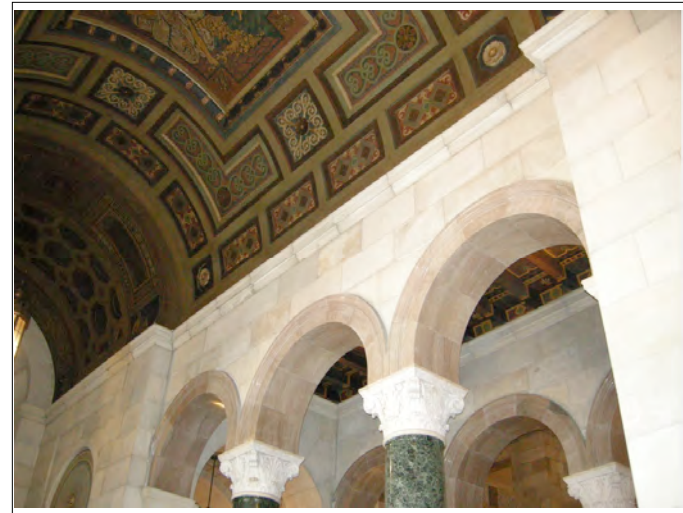
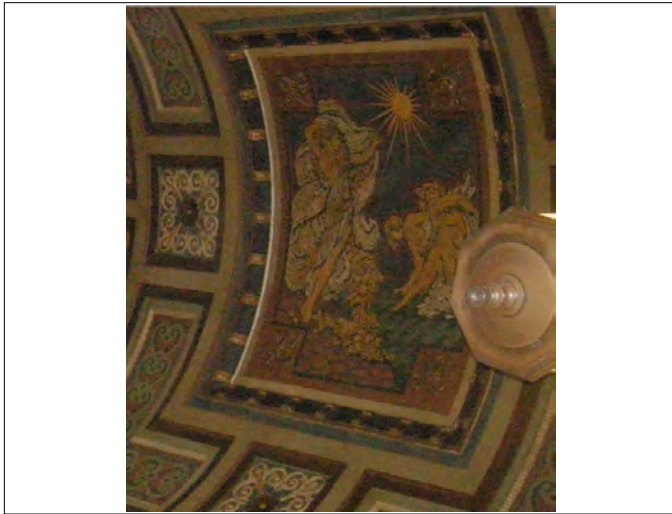
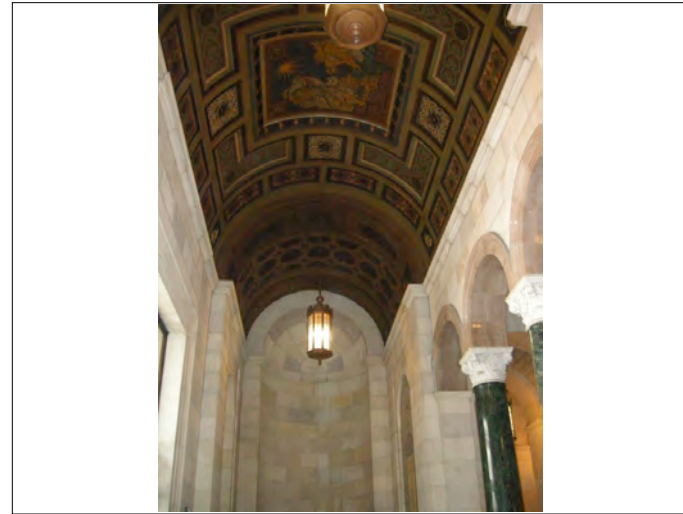
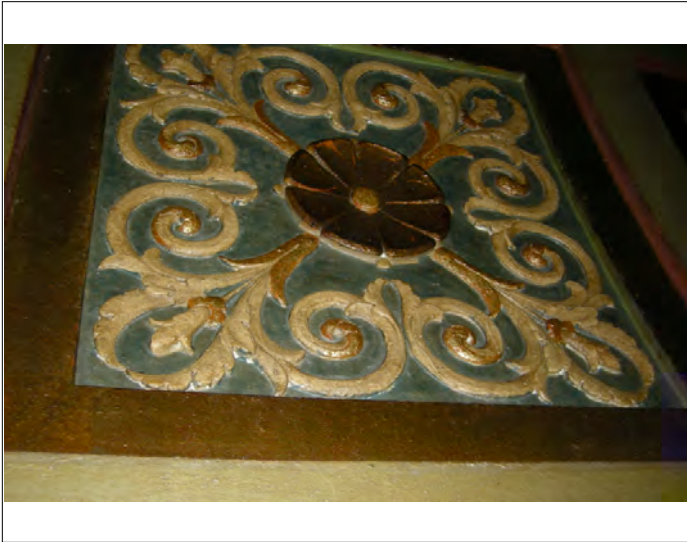
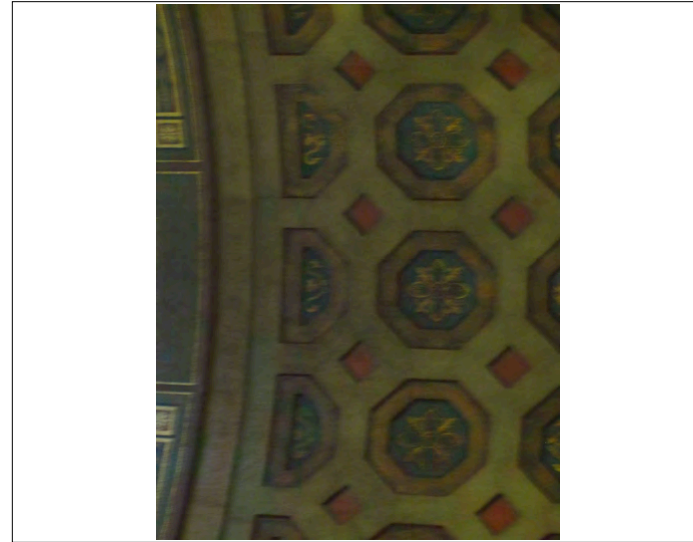
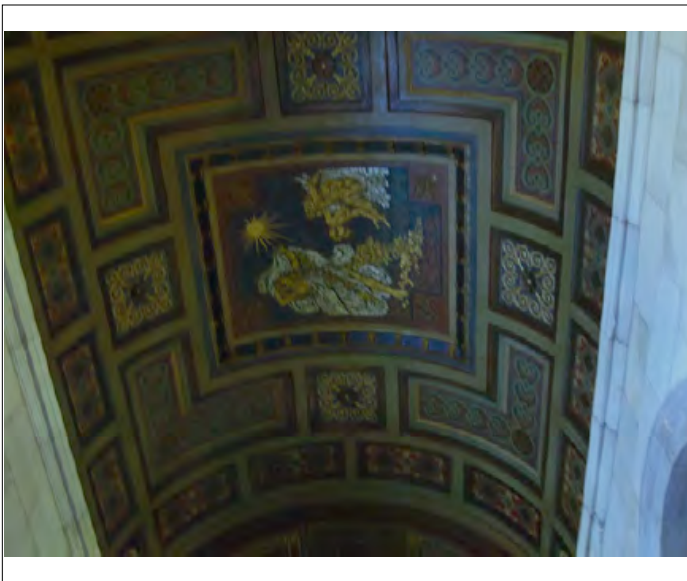
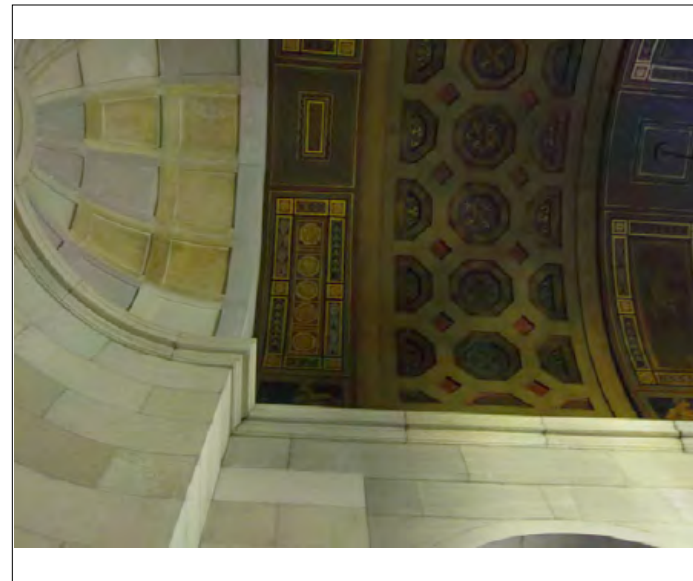
Overall Assessment	Generally good overall condition, with minor flake losses in paint, local staining, soiling.
Condition History / Previous Restoration	No reported retouching or repairs.
Structural Condition	Second panel from south end of barrel vault, peeling. Recessed coffers, south side of far south canvas, mounting peeling off.
Surface Condition	Barrel vault, south east point of panel (in corner), gold leaf thinning.

- Readhere with an appropriate adhesive system. A bulked, high-tack, neutral pH adhesive system that is capable of gap filling and retaining flexibility/resiliency may be appropriate. It should also be resistant to atmospheric moisture and biological attack. One option may be Lascaux acrylic adhesive, a dispersion of a thermoplastic acrylic polymer based on methyl methacrylate and butyl acrylate. The two types 360 HV and 498 HV are thickened with acrylic butylester. All types have a pH 8 - 9 and are biocide stabilized.

- Establish a maintenance log, noting the conditions and locations of retouchings. Supplement with digital photographs.
- A conservator should be consulted if flaking, loss, efflorescence, etc. occurs. The conservator can coordinate work that may be done as appropriate by decorative paint contractor.

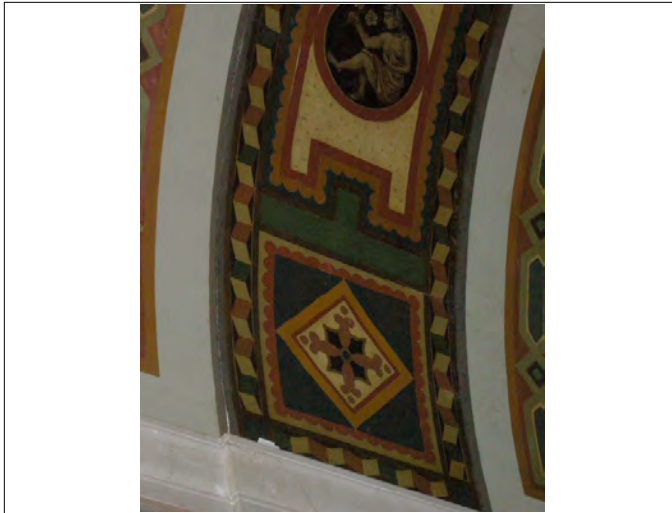
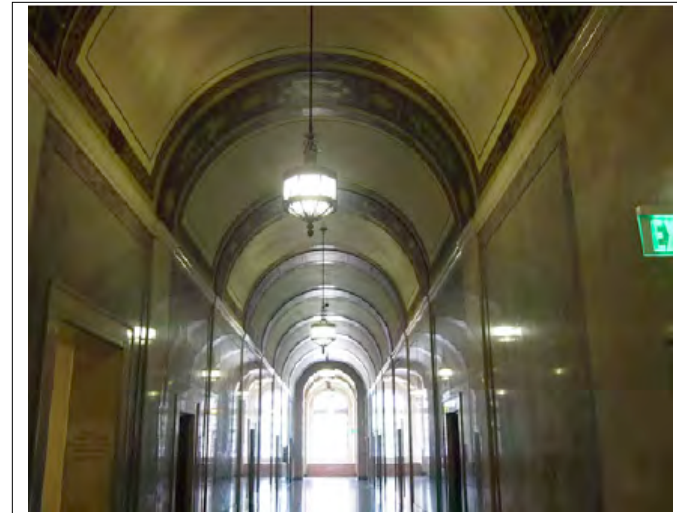
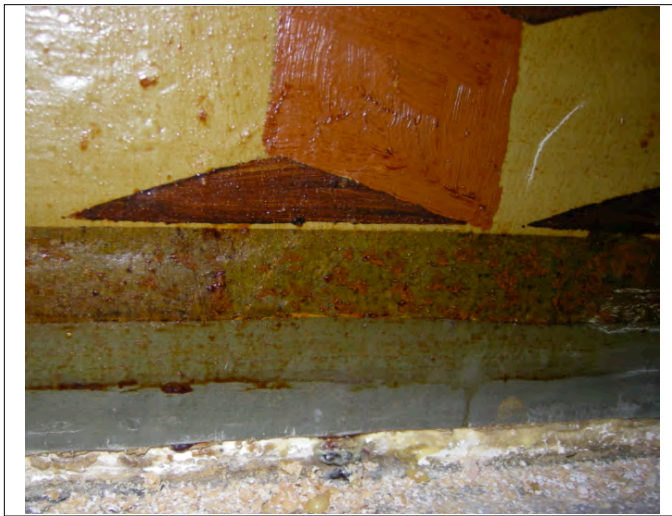
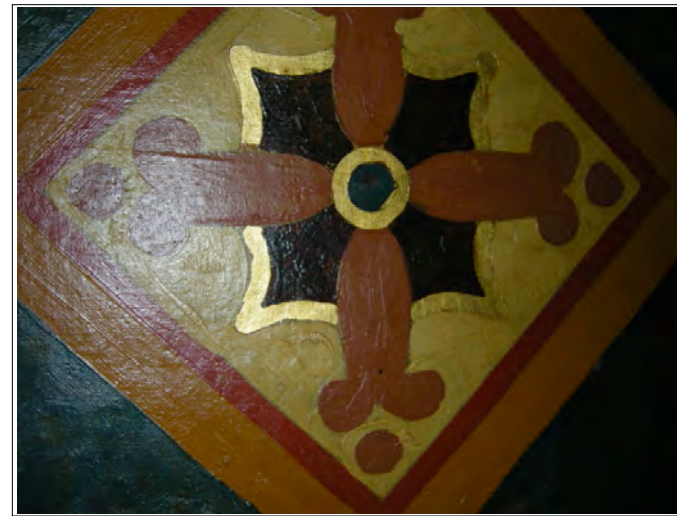
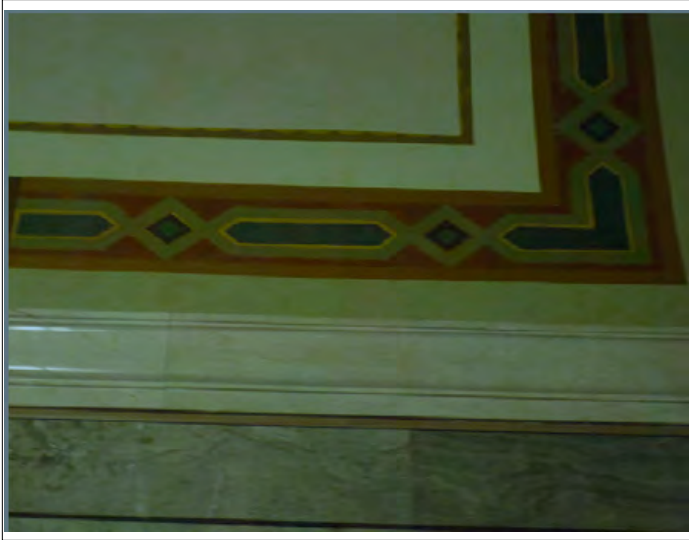
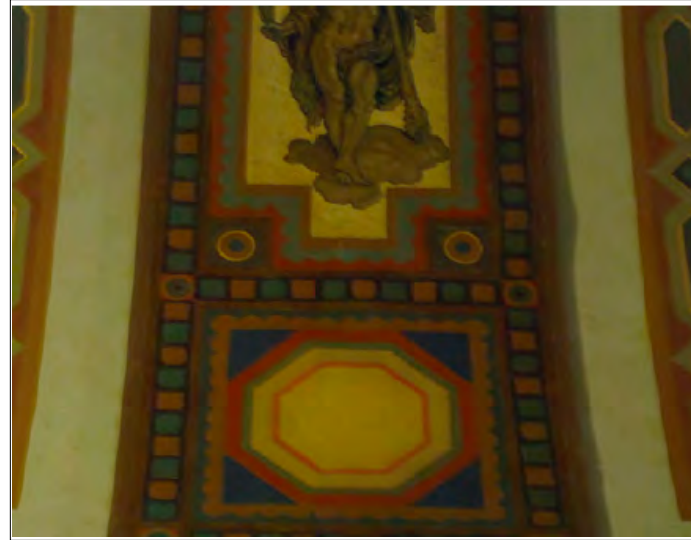
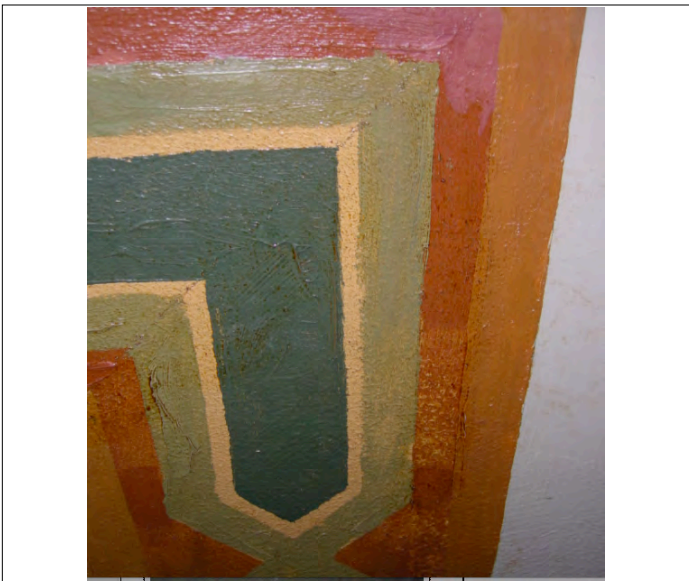
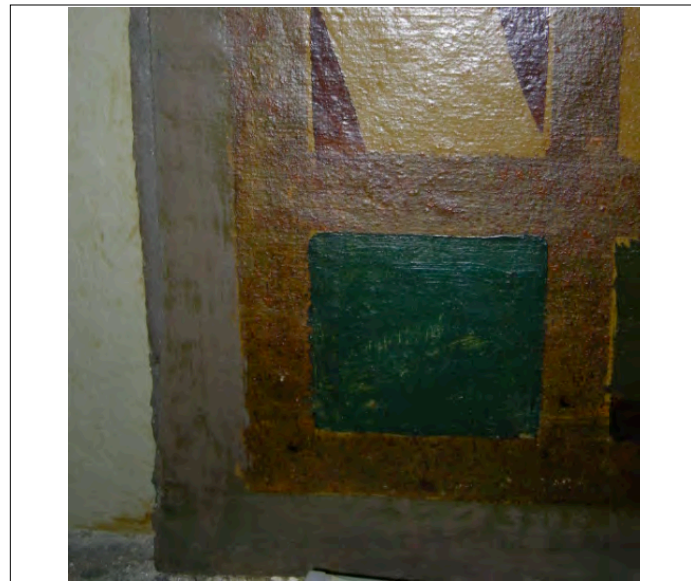
Overall Assessment	While the painted surfaces are largely intact, there has been some damage related to failure of marouflage adhesion, and a history of past repairs.
Condition History / Previous Restoration	Readhered areas of failed marouflage on vault ribs, with translucent, fluid adhesive emulsion; preliminary microchemical testing indicates PVA (iodine potassium iodide test, mixed results). Older adhesive is crystalline, powdering, golden to yellow, translucent. Slight swelling in toluene. Possibly animal glue. Presumably original, but possibly an earlier attempt at readhesion.
Structural Condition	Good structural condition of substrates. Some crumbling, powdering of plaster at areas of marouflage detachment. Not clear evidence of salts.
Surface Condition	South rib panel, east end, flaking at bottom. East side, canvas pulling away from wall revealing plaster substrate. Northernmost rib, marouflaged panel, detachment and drooping at apex of barrel vault. Amber-brown discoloration originally suspected to be mildew appears to be discolored resin accretion. Local inpaint/overpaint touchups are discolored.

- Readhere with an appropriate adhesive system. A bulked, high-tack, neutral pH adhesive system that is capable of gap filling and retaining flexibility/resiliency may be appropriate. It should also be resistant to atmospheric moisture and biological attack. One option may be Lascaux acrylic adhesive, a dispersion of a thermoplastic acrylic polymer based on methyl methacrylate and butyl acrylate. The two types 360 HV and 498 HV are thickened with acrylic butylester. All types have a pH 8 - 9 and are biocide stabilized.

- Document conditions found, test results, treatment rationale and treatment methods and materials used in a written report. Include digital images showing conditions before, during and after treatment. Include diagrams showing locations of conditions and treatments.

- Establish a maintenance log, noting the conditions and locations of retouchings. Supplement with digital photographs.
- A conservator should be consulted if flaking, loss, efflorescence, etc. occurs. The conservator can coordinate work that may be done as appropriate by decorative paint contractor.

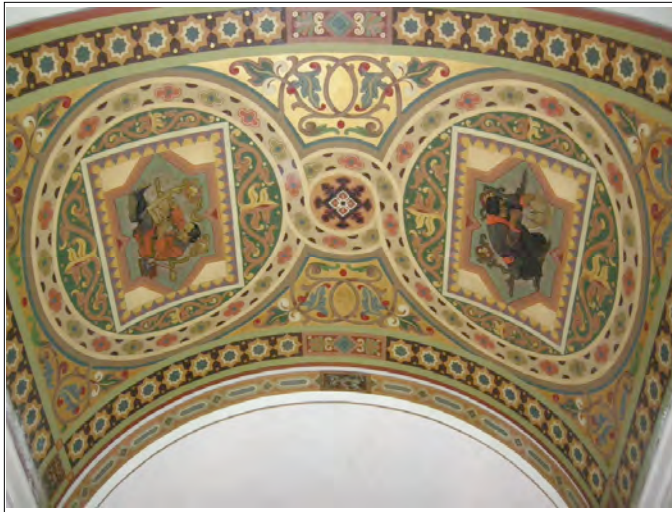
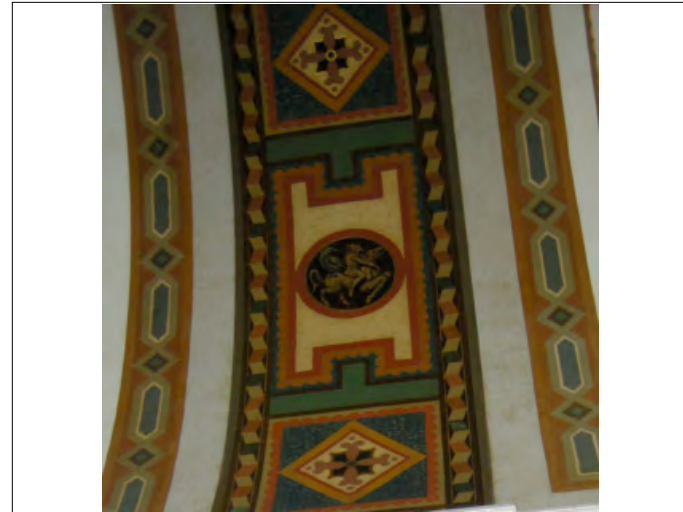
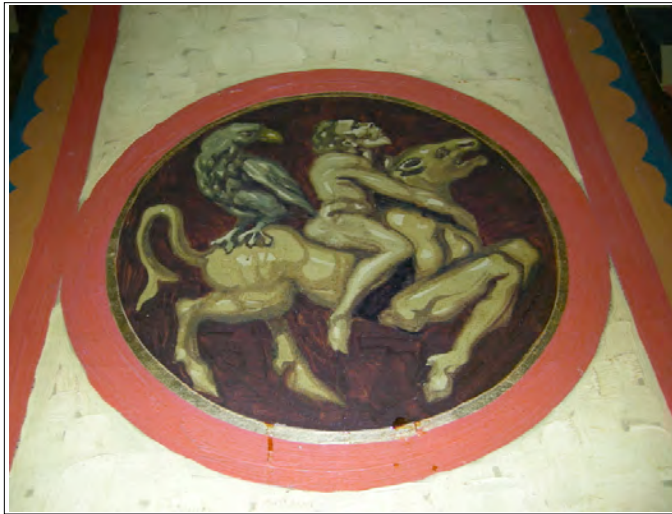
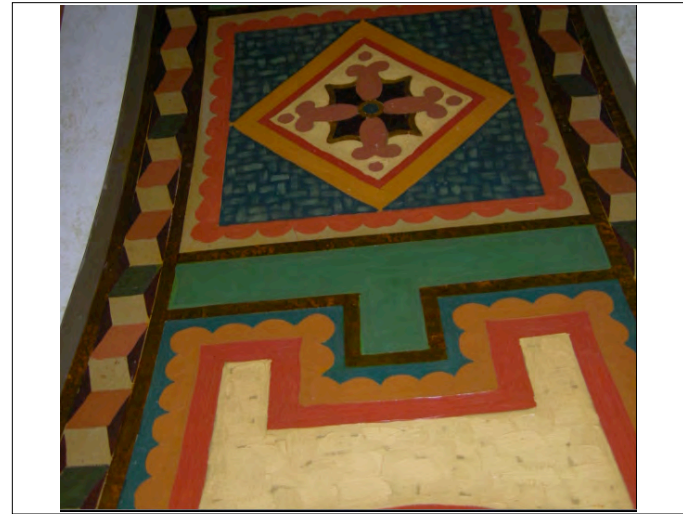
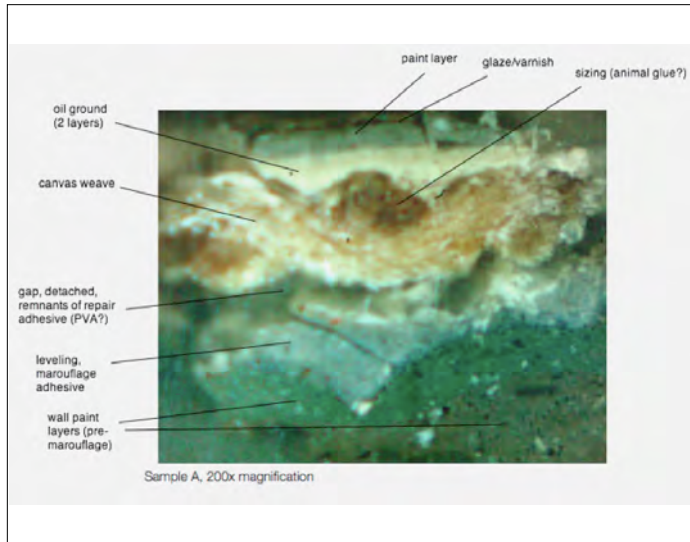
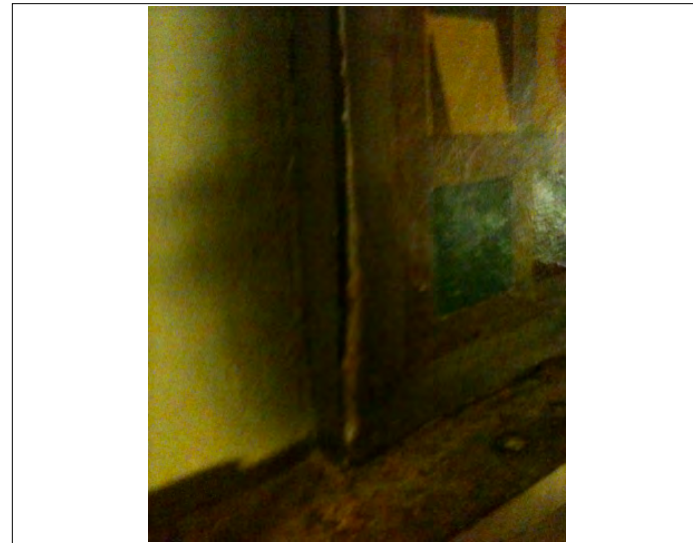
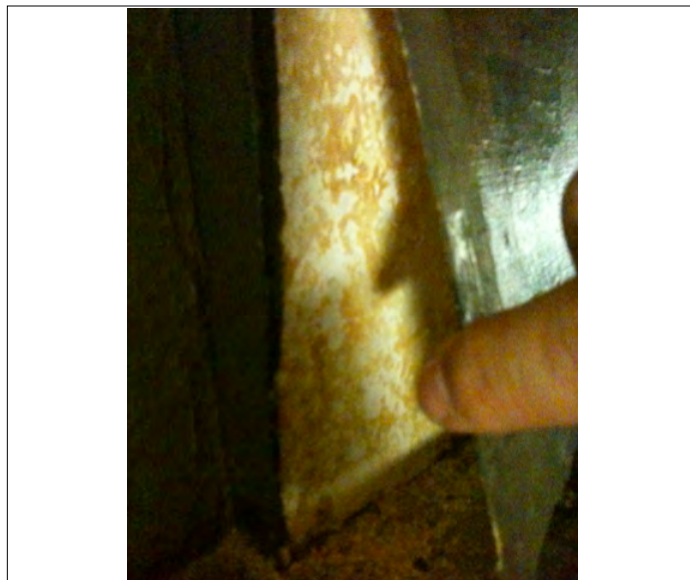
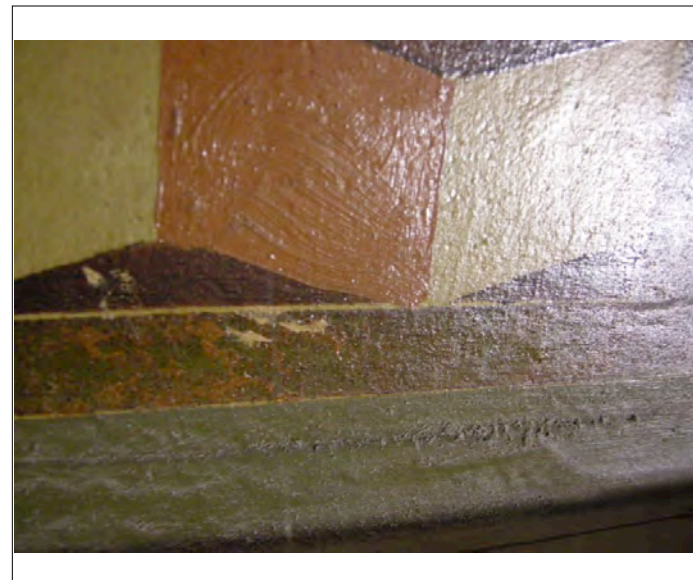
Overall Assessment	While the painted surfaces are largely intact, there has been some damage related to failure of marouflage adhesion, and a history of past repairs.
Condition History / Previous Restoration	Readhered areas of failed marouflage on vault ribs, with translucent, fluid adhesive emulsion; preliminary microchemical testing indicates PVA (iodine potassium iodide test, mixed results). Older adhesive is crystalline, powdering, golden to yellow, translucent. Slight swelling in toluene. Possibly animal glue. Presumably original, but possibly an earlier attempt at readhesion. No moisture infiltration has been noted since the seismic renovations. Some may have occurred prior to that.
Structural Condition	Good structural condition of substrates. Some crumbling, powdering of plaster at areas of marouflage detachment. Not clear evidence of salts.
Surface Condition	Bottom of both east and west have white chalky residue, related to above. First marouflaged rib at north end of hallway, at both east side and west side, exhibit tears in canvas, previously mended but adhesion failure has reintroduced stress and more tearing. Near the 4th canvas panel from south end of hall, there is local paint loss revealing plaster substrate; possible water damage along edge of marble cornice (where marble meets canvas) on east side. Local amber-brown staining, accretions on marouflaged roundels

- Readhere with an appropriate adhesive system. A bulked, high-tack, neutral pH adhesive system that is capable of gap filling and retaining flexibility/resiliency may be appropriate. It should also be resistant to atmospheric moisture and biological attack. One option may be Lascaux acrylic adhesive, a dispersion of a thermoplastic acrylic polymer based on methyl methacrylate and butyl acrylate. The two types 360 HV and 498 HV are thickened with acrylic butylester. All types have a pH 8 - 9 and are biocide stabilized.

- Document conditions found, test results, treatment rationale and treatment methods and materials used in a written report. Include digital images showing conditions before, during and after treatment. Include diagrams showing locations of conditions and treatments.

- Establish a maintenance log, noting the conditions and locations of retouchings. Supplement with digital photographs.
- A conservator should be consulted if flaking, loss, efflorescence, etc. occurs. The conservator can coordinate work that may be done as appropriate by decorative paint contractor.

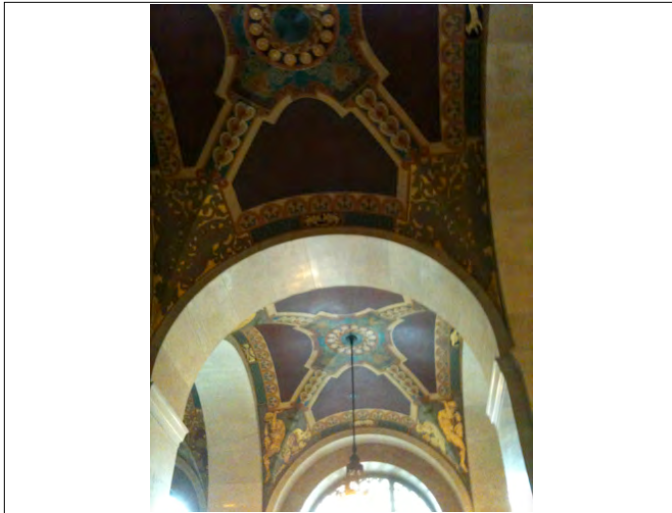
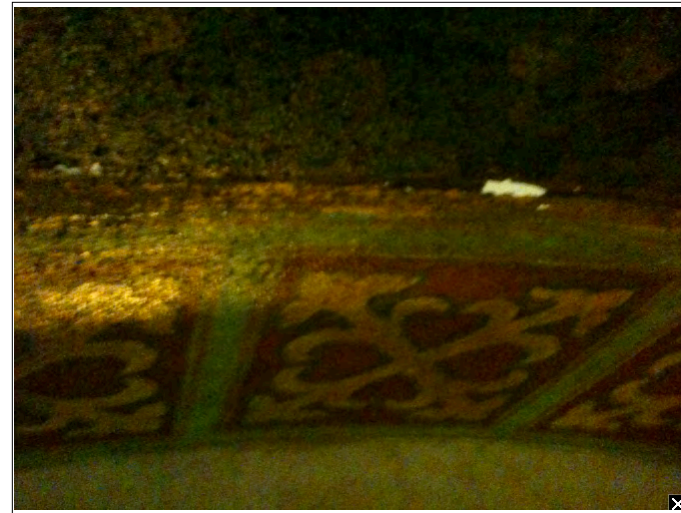
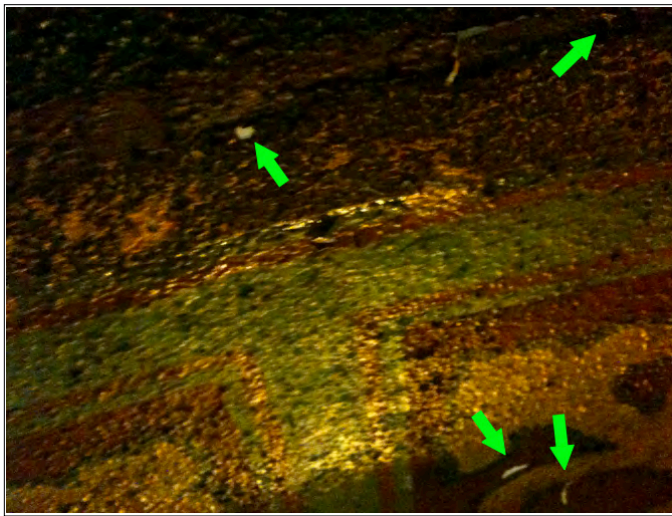
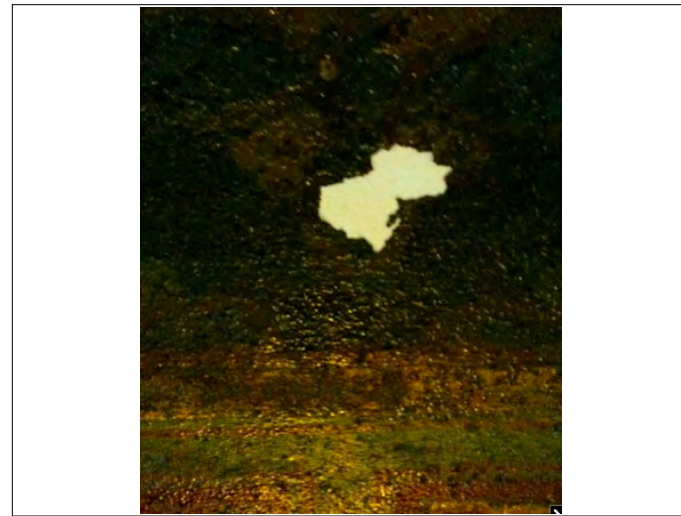
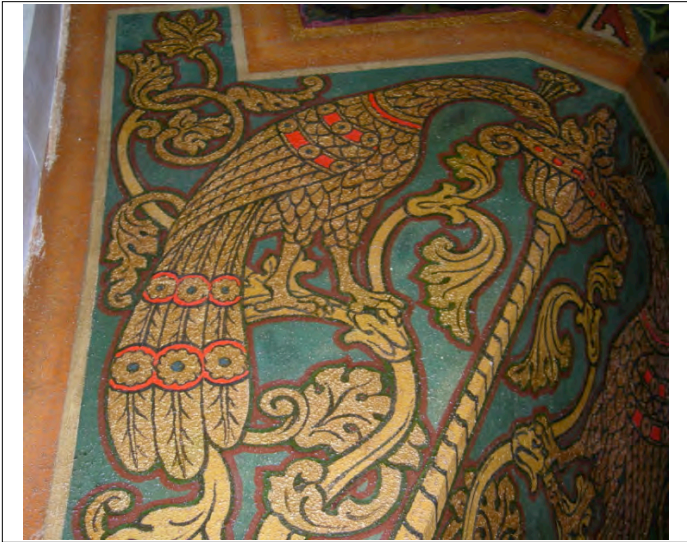
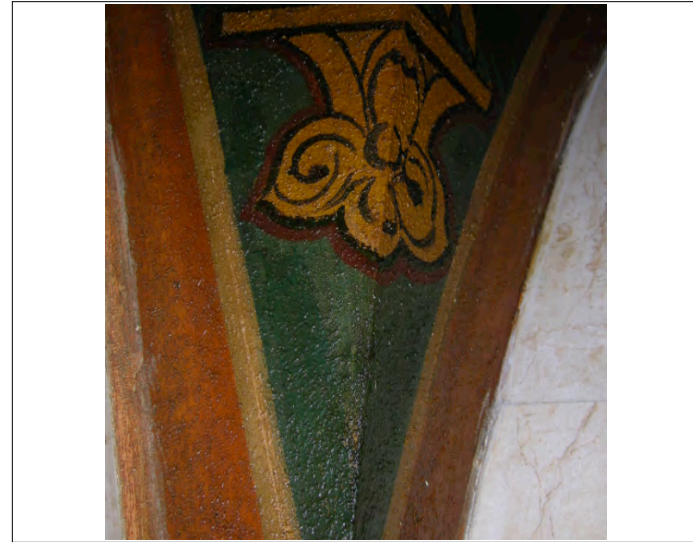
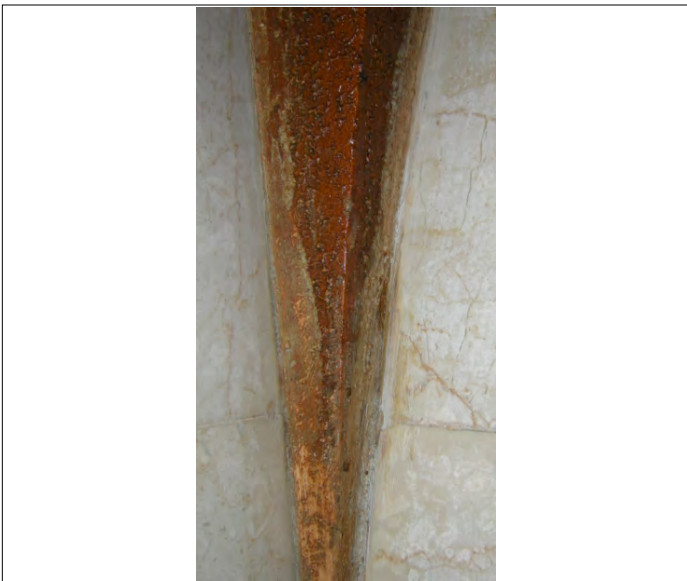
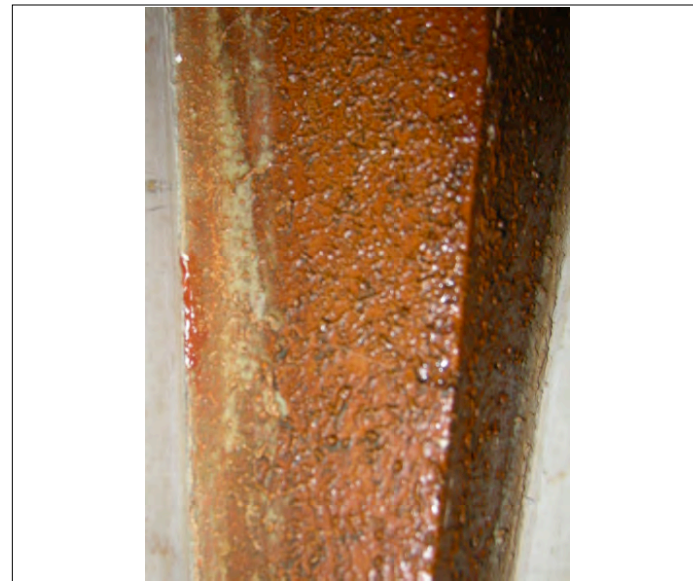
Thick varnish, in layers. Possible glue size on smooth plaster. (Gold leaf is present, possible overall sizing treatment?) Textured oil paint layers are relatively thick. Adding varnish may have added mass, and stress from drying causing shear forces to induce delamination. Microenvironment in blind delamination areas causes progressive loss of adhesion, esp. if moisture sensitive glue size is present? Localized, recurring limited to north groin vault. Possible earlier history of water leak, but no records of this.

Flaking paint in groin vaults, possibly related to earlier moisture intrusion because of evidence of a history of paint loss and touch-ups at north groin vault, but no evidence of staining, efflorescence, repairs, etc. No recent water leaks (at least since seismic retrofit project).

Severe flaking, incipient cleavage of paint layer at white plaster ground layer on north groin vault (south end of vault). Long term, ongoing problem, based on the various campaigns of toning/in-painting visible.

7 of 8 groin vaults have peeling, revealing smooth plaster substrate. Central north groin vault, NW point of groin vault (in organic pattern with peacock), paint chipping in vine pattern. North west, paint chipping revealing plaster substrate. West side of groin vault, SW of west center groin vault, second square on red fret pattern, peeling. South east groin vault, possible water damage at joint between marble and plaster. Southern most triangular section of center square lattice pattern (SW corner), paint peeling revealing plaster substrate. Main dome. gold flower - over paint? In-painting?
