**Environmental Description
Summary**

Main Feature Name Vaulted ceiling, walls, window surrounds in antechamber

Location Board of Public Works

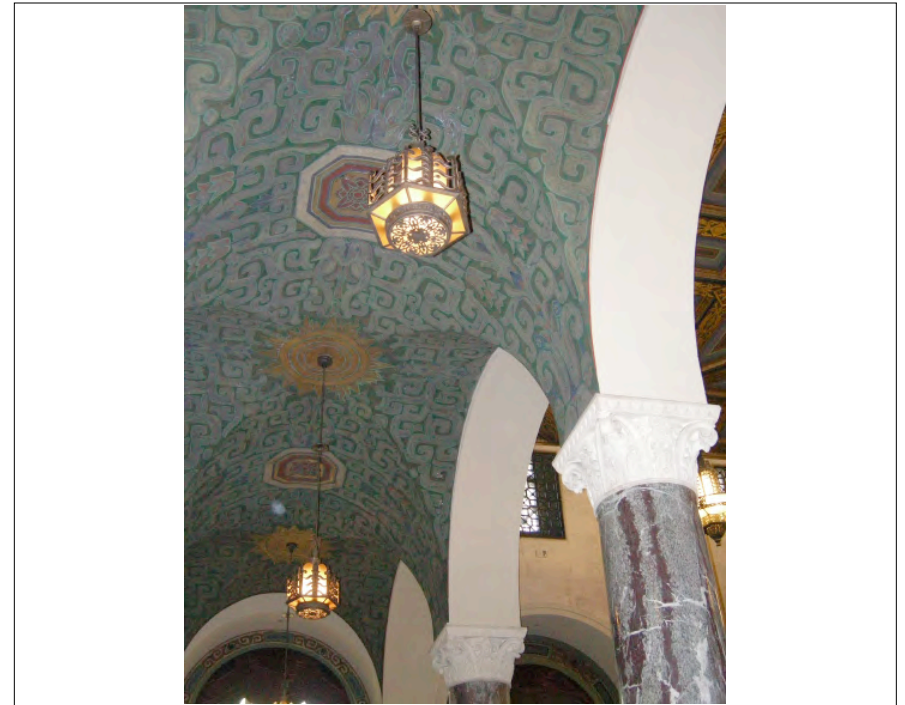
Flakes collected from representative color areas, at south end of north groin vault. Cross sections mounted; x-sections and back of flakes examined using visible light microscopy.

Overall Assessment	Overall good condition, with some minor paint loss, local staining. Retouched.
Condition History / Previous Restoration	Past history of minor touch-ups with oil paint over unfilled flake losses. Grime on walls from human contact, overpainted, scrubbed, etc. Tatyana Thompson conducted solubility and cleaning tests in 1999.
Structural Condition	Structural cracks in window surrounds, reported in 1999.
Surface Condition	Minor paint loss, local dark staining, e.g. at apex of vaults, grime, related abrasions from public contact on back wall, proximity of furniture, etc. Possible re-varnishing is exacerbating paint loss. Pinhole losses, presumably from lost sand grains.

- Determine extent of incipient cleavage of paint layers through a detailed surface mapping of all vaults.
- Inject/consolidate flaking and insecure areas with an appropriate adhesive.

- Continue testing removal of varnish, or reduction of varnish thickness. The varnish on a collected sample was found to be moderately soluble in a gel made with Triton X-100 in xylene and water (2:5:3, v:v). A small amount of triethanolamine (<1%) was added. It is possible that this gel worked on the presumed newer varnish, leaving older, more oxidized varnish or oil glaze intact.

- Remove inappropriate varnish layers with the selected solvent/gel system. Small areas at a time may need to be treated.
- Isolate losses with a reversible barrier resin. Fill losses to emulate the surrounding sanded texture with an appropriate fill material.

- Inpaint fills with appropriate media to closely match the surrounding painted surfaces.
- Document conditions found, test results, treatment rationale and treatment methods and materials used in a written report. Include digital images showing conditions before, during and after treatment. Include diagrams showing locations of conditions and treatments.

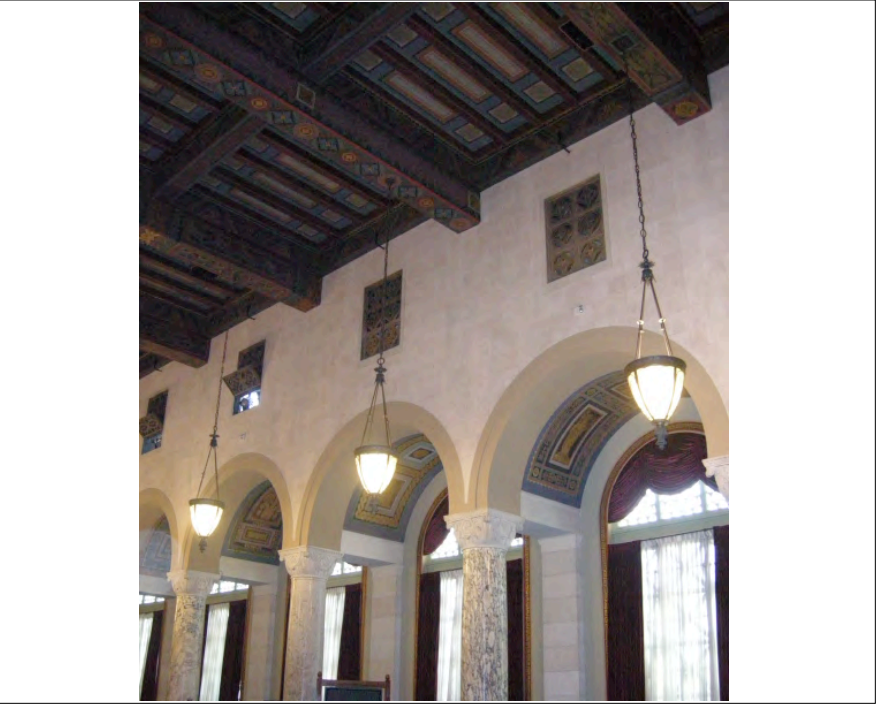
Binocular survey indicates the ceiling is in good overall condition, but heavily soiled with dark grime. Any past inpainting or other touch-ups are not apparent. Paint on Celotex ceiling tiles are highly sensitive to water, very friable, especially the blue-green color, according to Thompson report (1999). Blind arches on back wall are stable but soiled. Some sensitivity to water found by Thompson on all but gold, beige and black banding.

No significant work reported. Tatyana Thompson conducted solubility and cleaning tests in 1999.

Good structural condition, based on remote observation. Internal structure, reinforcements should be confirmed and evaluated in the future. Window opening marouflage panels appear to be well-adhered.

Some general darkening has occurred due to soiling and oxidation of coatings, etc. Abrasion and grime on lower areas within contact of public. Water soluble paint is friable.

- Determine extent of incipient cleavage of paint layers through a detailed surface mapping of all vaults.
- Written and photographic documentation of condition before, during and after treatment. Include diagrams showing conditions and local treatments performed.

- Stabilize flaking paint with a heat-activated adhesive based on ethylene vinyl acetate (e.g. Beva D8 or Beva 371), followed by realignment of distorted paint using controlled, gentle heat and pressure, e.g. with a heated spatula or tacking iron. Protect the paint surfaces with silicone coated mylar during this process. Clean excess adhesive using an appropriate organic solvent (e.g. VM&P naphtha and/or xylene.)

- Superficially clean the ceiling to remove loosely adhered dust and soiling with gentle vacuum pressure and soft, natural bristle brushes.
- Continue testing removal of modern varnish, or reduction of varnish thickness.

- Remove or reduce added varnish layers with the selected solvent/gel system. Small areas at a time may need to be treated.
- General cleaning of ceiling with dry cleaning pads, e.g. Wishab pads or Gonzo soot sponges, based on testing.

- Surface clean surfaces not sensitive to water using distilled or deionized water and cotton swabs. Confirm presence of transparent coating on gold colored areas. After cleaning areas of coated metal leaf or metallic paint, re-coat locally with an appropriate reversible varnish to help prevent tarnishing.

- Reduce old overpaint, if present, using an appropriate organic solvent or aqueous system, based on solubility testing.
- Fill losses to closely match the surrounding surface topography and texture with an appropriate compatible fill material, e.g. an acrylic paste (e.g. Flugger). Imitate sanded surface as appropriate.

- Inpaint fills with an appropriate medium to closely match the surrounding surfaces. Paints based on low molecular weight resin such as Gamblin conservation colors (Regalrez 1094) or Golden MSA colors. Supplement with dry pigments as appropriate.

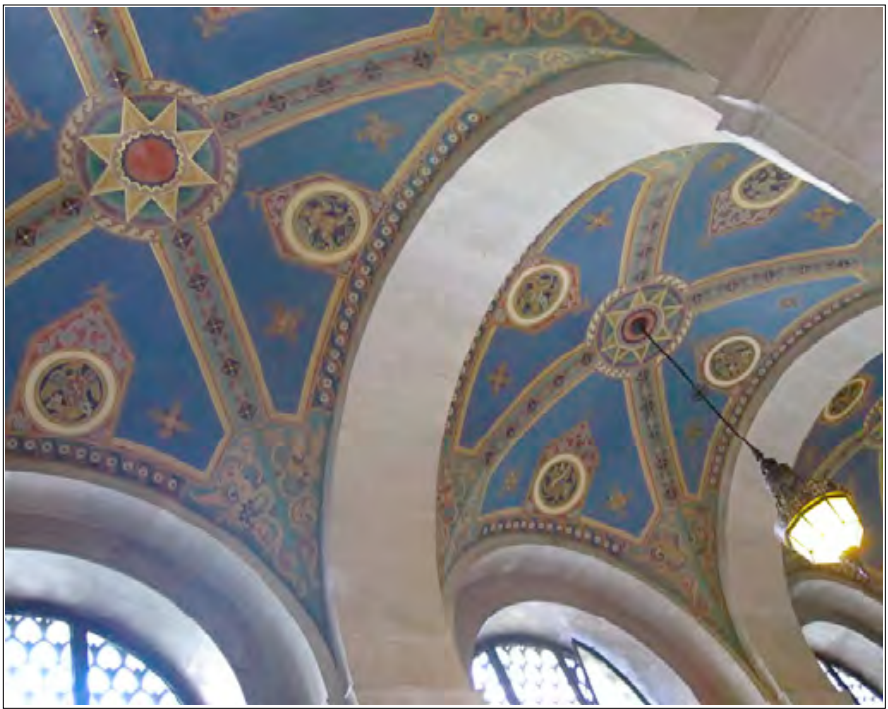
Overall Assessment	Generally good condition overall, some active flaking at lower corners of vault springs.
Condition History / Previous Restoration	<p>Retouching, various campaigns. Mismatched green touch-up paint applied over loss without infilling.</p> <p>Comparison with archival photo, ca. 1928, shows the design and tonal range of the fields, etc. is relatively intact today. (See photo from USC Digital Library archive, ID# examiner-m13189 (part of Los Angeles Examiner Prints Collection, late 1920's - 1961).</p>
Structural Condition	Good apparent structural condition. Marouflage elements appear well adhered.
Surface Condition	Star over stairs in center vault, paint peeling (speck) revealing plaster substrate, SW.

- Written and photographic documentation of condition before, during and after treatment. Include diagrams showing conditions and local treatments performed.

- Stabilize flaking paint with a heat-activated adhesive based on ethylene vinyl acetate (e.g. Beva D8 or Beva 371), followed by realignment of distorted paint using controlled, gentle heat and pressure, e.g. with a heated spatula or tacking iron. Protect the paint surfaces with silicone coated mylar during this process. Clean excess adhesive using an appropriate organic solvent (e.g. VM&P naphtha and/or xylene.)

- Superficially clean the ceiling to remove loosely adhered dust and soiling with gentle vacuum pressure and soft, natural bristle brushes.
- General cleaning of ceiling with dry cleaning pads, e.g. Wishab pads or Gonzo soot sponges, based on testing.

- Surface clean surfaces not sensitive to water using distilled or deionized water and cotton swabs. Confirm presence of transparent coating on gold colored areas. After cleaning areas of coated metal leaf or metallic paint, re-coat locally with an appropriate reversible varnish to help prevent tarnishing.

- Reduce old overpaint, if present, using an appropriate organic solvent or aqueous system, based on solubility testing.
- Fill losses to closely match the surrounding surface topography and texture with an appropriate compatible fill material, e.g. an acrylic paste (e.g. Flugger).

- Inpaint fills with an appropriate medium to closely match the surrounding surfaces. Paints based on low molecular weight resin such as Gamblin conservation colors (Regalrez 1094) or Golden MSA colors. Supplement with dry pigments as appropriate.

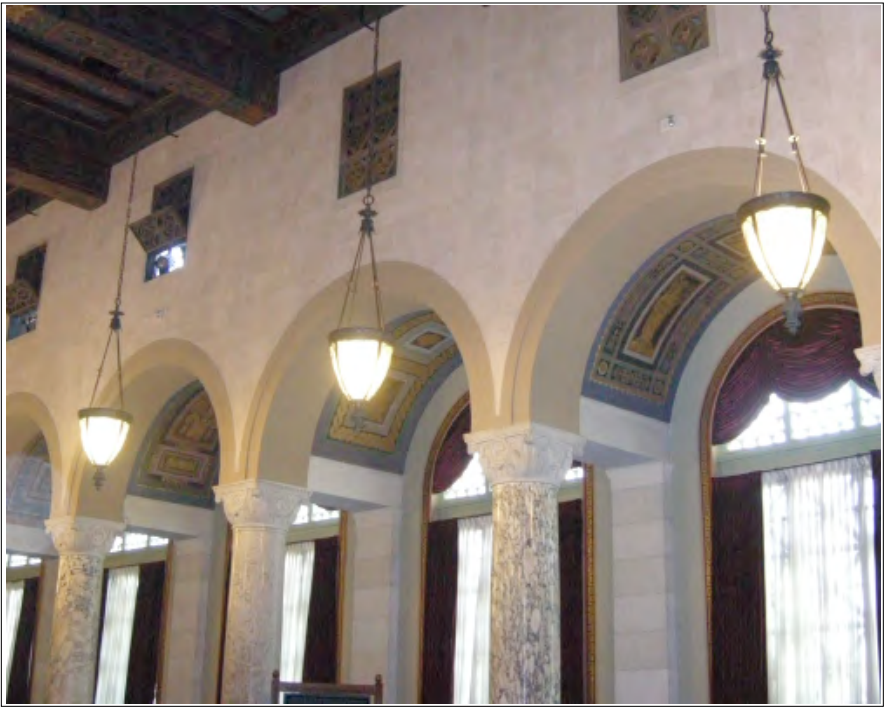
Overall Assessment	Dark staining from moisture damage, cracks in plaster, friable paint overall, except gold areas, reported by Thompson. Many small pinhole losses, presumably due to loss of sand grains, described in the Thompson report.
Condition History / Previous Restoration	<p>Local areas of inpainting scattered throughout murals. Tatyana Thompson conducted solubility and cleaning tests in 1999. Murals may have been treated since then, as surfaces no longer seem dry and chalky; possibly coated or consolidated. Pinhole losses may have been inpainted. Stains may have been at least partially overpainted.</p> <p>Based on comparison with archival photos (USC Digital Library ID# chs-m1854, Part of Los Angeles Area Chamber of Commerce Collection, 1890-1960 USC; and ID# chs-m21101, California Historical Society Collection, 1860-1960 USC), the tonal range and contrast between background and design elements remains consistent since 1928.</p>

Structural Condition	Cracks, moisture-related damage, presumably stabilized in seismic rehabilitation project.
Surface Condition	Some general darkening has occurred due to soiling and oxidation of coatings, etc. Added consolidant or coating may be contributing to loss of adhesion of paint at ground layer.

- Determine extent of incipient cleavage of paint layers through a detailed surface mapping of all vaults.
- Inject/consolidate flaking and insecure areas with an appropriate adhesive.

- Continue testing removal of varnish, or reduction of varnish thickness. The varnish on a collected sample was found to be moderately soluble in a gel made with Triton X-100 in xylene and water (2:5:3, v:v). A small amount of triethanolamine (<1%) was added. It is possible that this gel worked on the presumed newer varnish, leaving older, more oxidized varnish or oil glaze intact.

- Remove inappropriate varnish layers with the selected solvent/gel system. Small areas at a time may need to be treated.
- Isolate losses with a reversible barrier resin. Fill losses to emulate the surrounding sanded texture with an appropriate fill material.

- Inpaint fills with appropriate media to closely match the surrounding painted surfaces.
- Document conditions found, test results, treatment rationale and treatment methods and materials used in a written report. Include digital images showing conditions before, during and after treatment. Include diagrams showing locations of conditions and treatments.

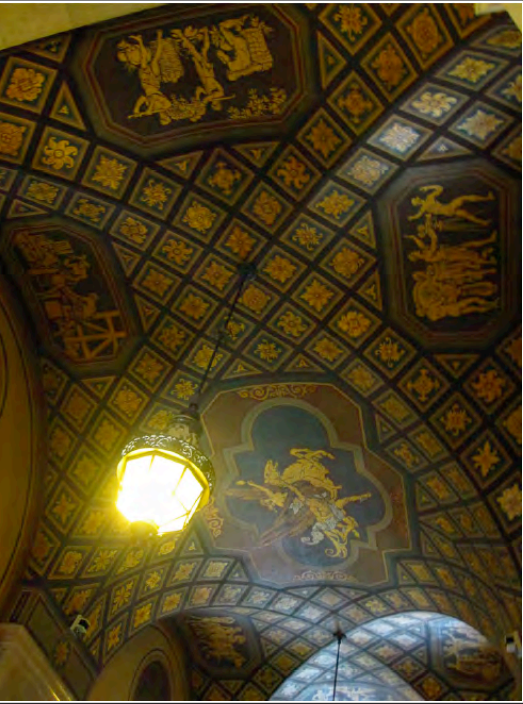
Overall Assessment Generally in good condition. Some darkening, oxidation of surface may have occurred. Generally well protected area.

Structural Condition Good, with no apparent losses, erosion of details, cracks.

Surface Condition Good, possible darkening, oxidation of glaze or other clear coat (varnish) if present.

- Written and photographic documentation of condition before, during and after treatment. Include diagrams showing conditions and local treatments performed.

- Stabilize flaking paint with a heat-activated adhesive based on ethylene vinyl acetate (e.g. Beva D8 or Beva 371), followed by realignment of distorted paint using controlled, gentle heat and pressure, e.g. with a heated spatula or tacking iron. Protect the paint surfaces with silicone coated mylar during this process. Clean excess adhesive using an appropriate organic solvent (e.g. VM&P naphtha and/or xylene.)

- Superficially clean the ceiling to remove loosely adhered dust and soiling with gentle vacuum pressure and soft, natural bristle brushes.
- General cleaning of ceiling with dry cleaning pads, e.g. Wishab pads or Gonzo soot sponges, based on testing.

- Surface clean surfaces not sensitive to water using distilled or deionized water and cotton swabs. Confirm presence of transparent coating on gold colored areas. After cleaning areas of coated metal leaf or metallic paint, re-coat locally with an appropriate reversible varnish to help prevent tarnishing.

- Reduce old disfiguring overpaint, if present, using an appropriate organic solvent or aqueous system, based on solubility testing.
- Fill losses to closely match the surrounding surface topography and texture with an appropriate compatible fill material, e.g. an acrylic paste (e.g. Flugger).

- Inpaint fills with an appropriate medium to closely match the surrounding surfaces. Paints based on low molecular weight resin such as Gamblin conservation colors (Regalrez 1094) or Golden MSA colors. Supplement with dry pigments as appropriate.

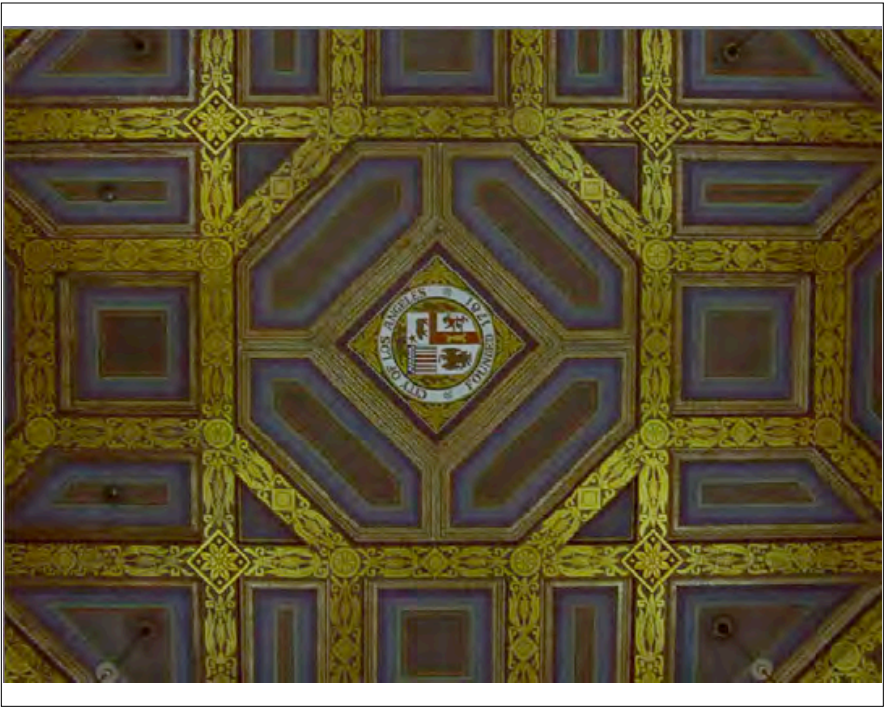
Binocular survey indicates the ceiling is in good overall condition. Any past inpainting or other touch-ups are not apparent. Darkened overall.

Good structural condition, based on remote observation. Internal structure, reinforcements should be confirmed and evaluated in the future.

General darkening may have occurred due to soiling and oxidation of coatings, etc. Hall going into Board of Public Works: east side, paint flaking revealing white plaster substrate (west, south corner of center coffer). A dark-edged stain remains on central east side of ceiling, approximately 1 foot dia.

Treatment Recommendations Superficial cleaning to remove adhered soiling and dust.
