LOS ANGELES FIRE DEPARTMENT

SUBJECT: BOYD STREET INCIDENT REPORT

Los Angeles City Fire Department Informational Summary Report

**May 16, 2020
Boyd Incident
CA-LFD-001073**

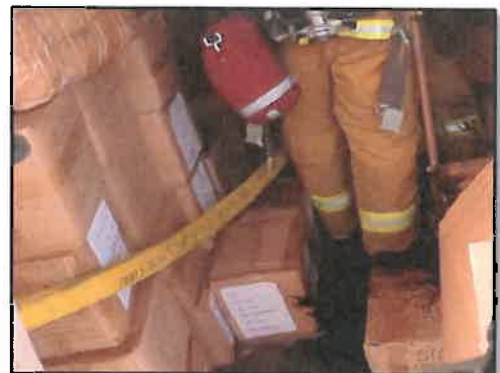
The aisleyway to Unit A was approximately 42" wide and was strewn with boxes and copious amounts of melted candle wax. The cluttered aisle was lined with commercial storage racks on either side. In the front, they were loaded with boxes, stacked to the ceiling, comprised of glass jars, candles, vapes, pre-rolled cones and various smoking products. In the rear portion of the occupancy, pallets of boxes blocked the aisleyway.

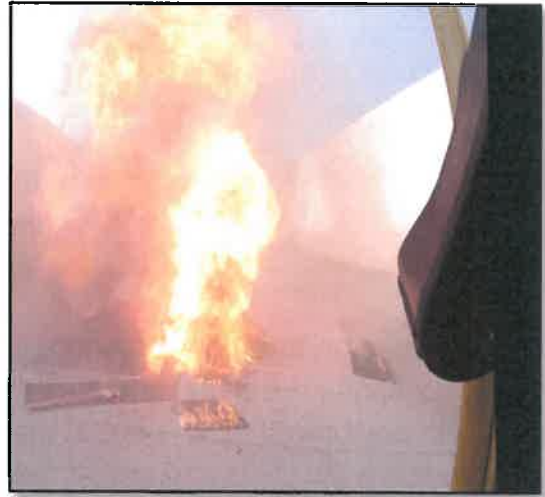
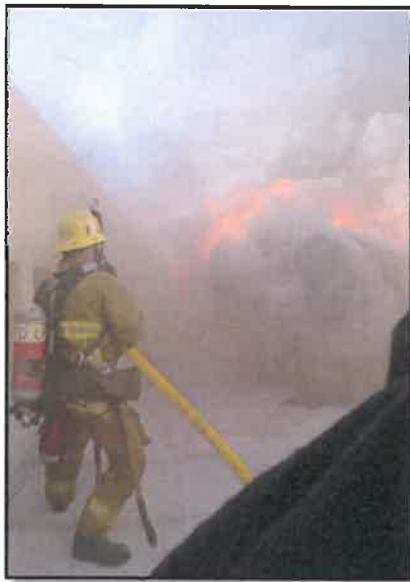
At 18:37:30 hours, Roof Division communicated with the IC and stated, "IC from Roof Division... you have exposures to the Bravo and Delta side. We have a hole opened up. We're getting heavy fire out of our hole toward the Charlie side." The original ventilation hole, after being extended twice, was cut to approximately 8' long by 6' wide.

Heavy fire pushed out of the ventilation hole, forcing the roof team to back away from the operation. Deciding to don structural gloves at this point, A/O gave the chainsaw to TILL and provided direction for TILL to start a new ventilation hole approximately 6' back from the initial heat hole and to work against construction. TILL initiated a new ventilation hole and the roof team began to pull the material. Pressurized smoke surged from both ventilation holes and the flames that followed were approximately 20' to 30' high.

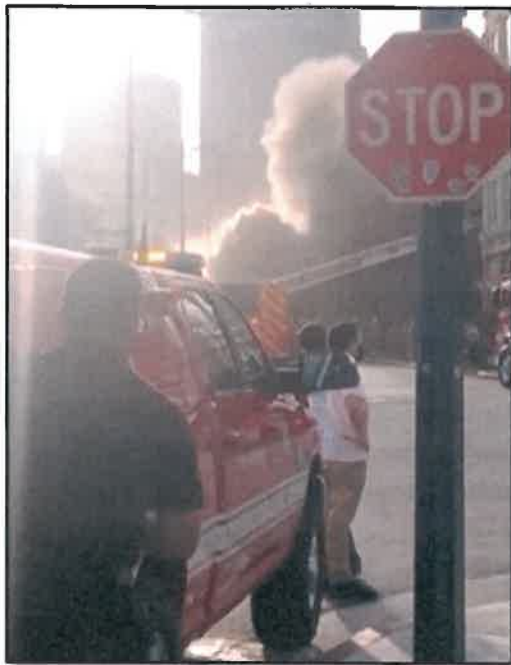
At 18:38:42 hours, in the front of the building, “dirty” black smoke pushed out from Unit A across the street, enveloping the firefighters operating in front of and adjacent to the involved occupancy. As they backed up from the entrance, the smoke ignited, sending approximately 30’ flames across the street and into the air.

As the smoke ignited and began to roll out of the Alpha side, fire began to appear from a rolling steel door on the Charlie side of Unit A, and rapidly expanded into an evolving fire ball. Small containers of nitrous oxide chargers ruptured, shot through the roof as well as out of the Charlie portal.

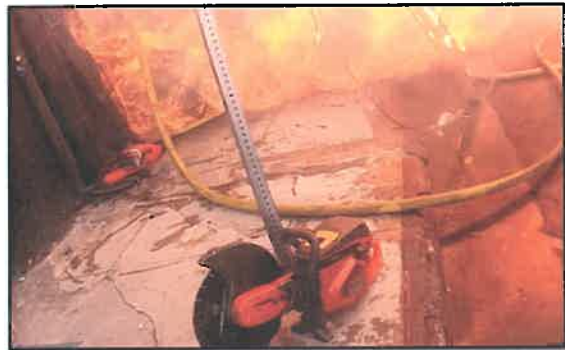
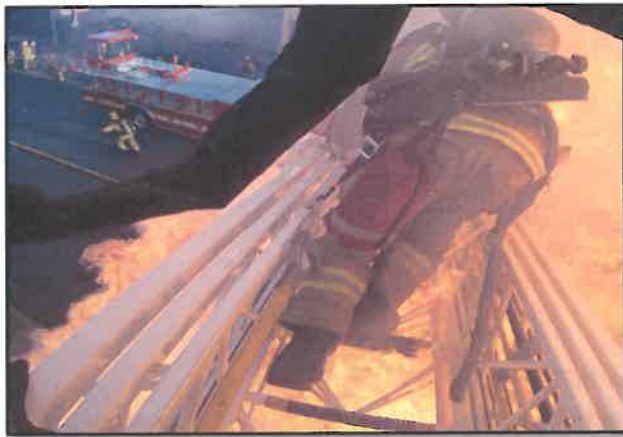
On the Alpha side, flames disappeared momentarily and the smoke appeared to temporarily diminish. Then without warning, an enormous fire ball blowtorched out of the structure reaching across the street. The fire ball emanated from the front of Unit A, followed by Unit B. Fire was seen reaching the buildings across the street and rising into the atmosphere approximately 60’ high above the roof line. It scorched everything in its path, including the Truck and the rear portion of the Engine.

As the fire engulfed the interior fire attack teams and blowtorched out of the units, C1 was outside the occupancy after being warned by ENG1. HYD1 and ATTN2 were close to the exit and were forced out across the street. ATTN1 and HYD2 had fire blow past them as they crawled to escape the intense heat. Deeper into the interior, DRVR2 maneuvered around the rolling step ladder, crawled through the flames and was pulled from the Alpha side portal into the street. NOZ1 negotiated the same step ladder and found the cinder block wall to reference for escape. NOZ2 crawled over boxes, struggled with the ladder and crawled to the portal to be pulled out by other firefighters. C2 was the last one out and managed to squeeze past the rolling step ladder and crawl through the excess storage until an awaiting firefighter pulled him out from inside the structure.

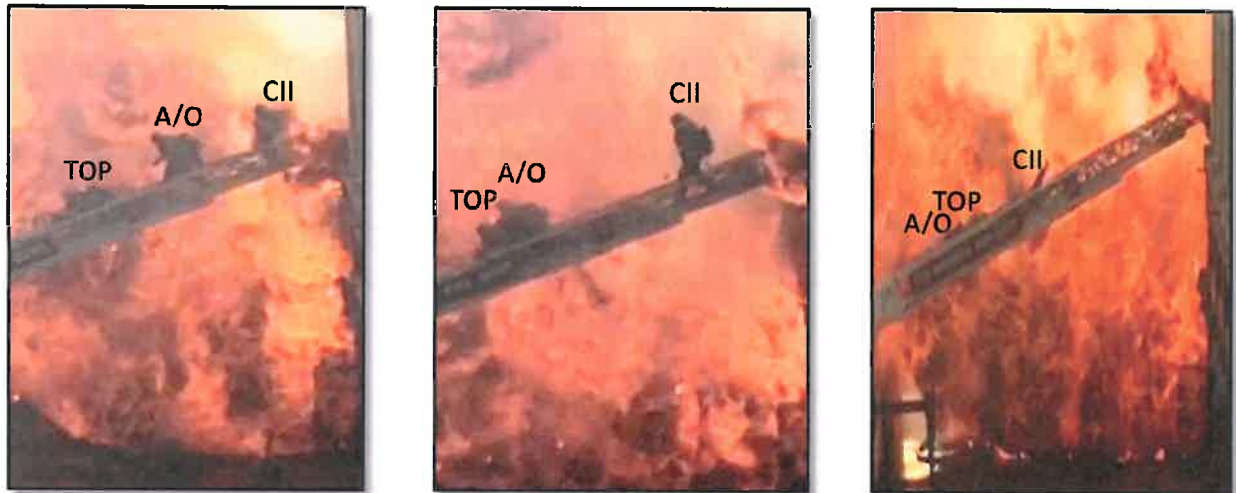
As TOP and A/O attempted to get free from being entangled with each other, their axes became wedged in the aerial ladder. One of the axes splintered from the force and one scabbard separated from the leather belt, leaving the axes wedged on the aerial ladder. Entangled with each other, TOP and A/O forcefully pushed themselves down the rungs until they both ended up face down in the aerial ladder. At the same time, CII fell into the ladder face first after missing a step and all three were engulfed in intense fire for several seconds. Due to the intense heat, several drop bags melted and fell to the ground. Even though TOP and A/O were still entangled, they managed to fight their

way down the aerial, each of them falling out onto the turntable deck. Eventually, CII was able to stand up and walk the remaining portion of the aerial ladder until he paused and sat down on the rungs at the base of the aerial.

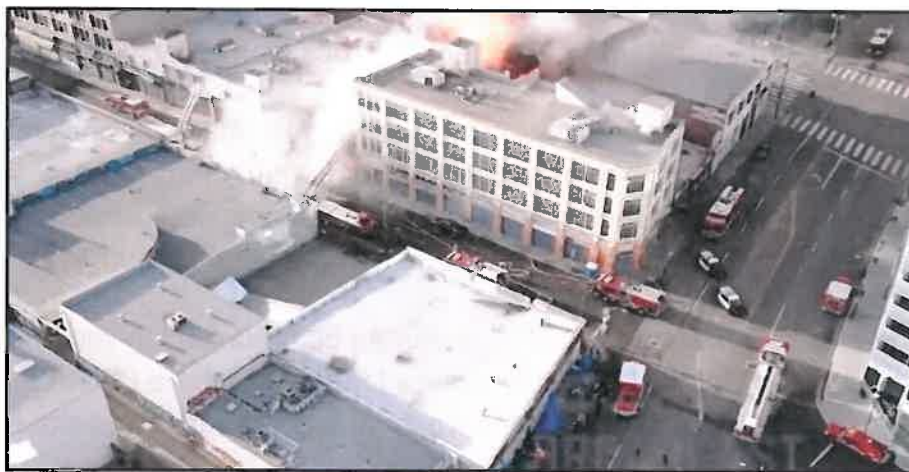
The extreme fire phenomenon lasted for approximately 45 seconds before it receded back into the structure. Intense fire conditions continued to show from the roof and Charlie side for the next minute.

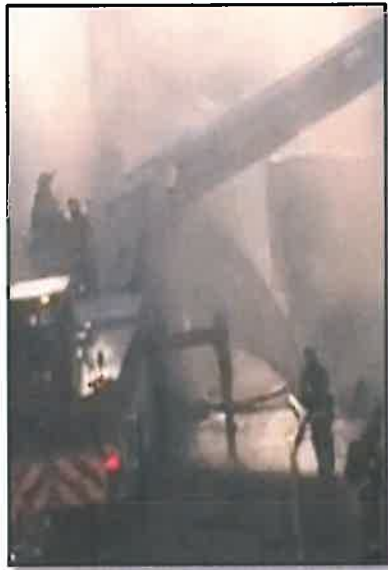
Firefighters from the interior came out one by one. At the turntable of the Truck, TOP was pulled by TILL and jumped from the turntable deck to the ground. TILL reached up and pulled A/O off the pedestal onto ATTN8 and then assisted CII down the rest of the aerial ladder. CII descended from the turntable to the ground.
