SUPPLEMENTAL HISTORIC STRUCTURE REPORT

HOLLYHOCK HOUSE

HOLLYHOCK HOUSE
CITY OF LOS ANGELES
LOS ANGELES COUNTY, CALIFORNIA

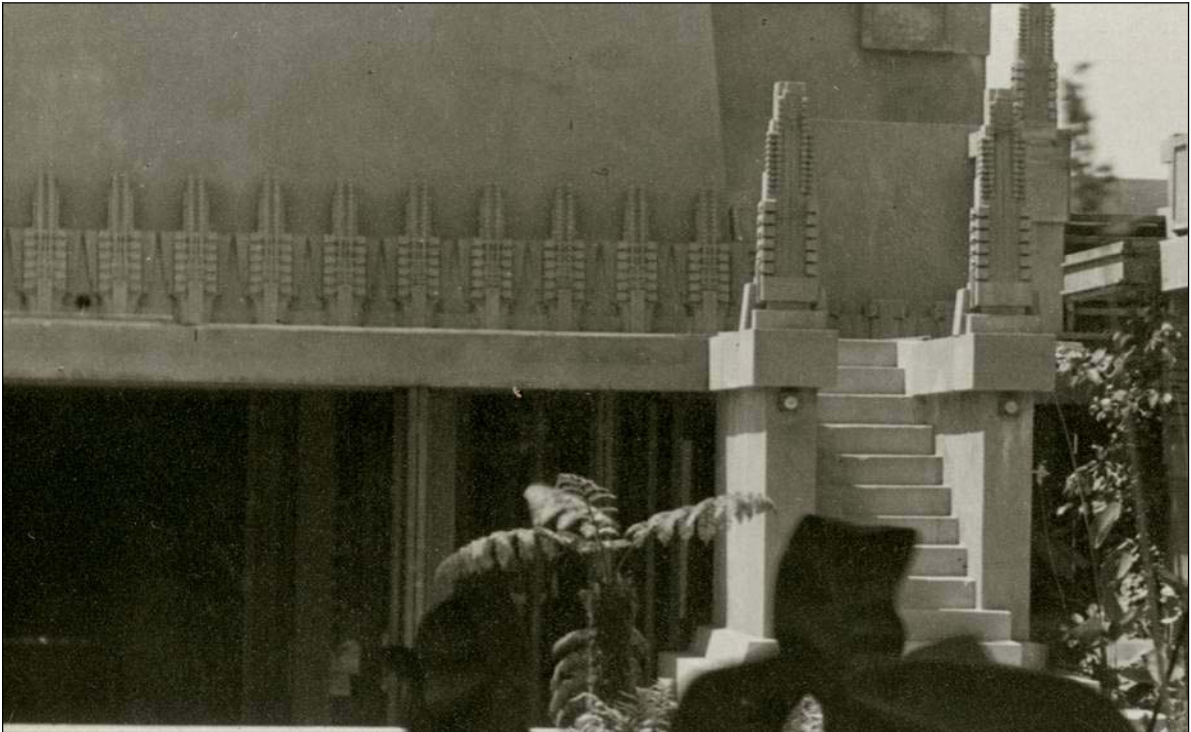
Figure 1: Close-up from a 1921 photograph depicting part of the porch, porch roof terrace, and staircase. No ceramic tile is present on the porch roof, nor are the concrete curbs that currently run across the top of the staircase. Photo courtesy Hollyhock House Archives.

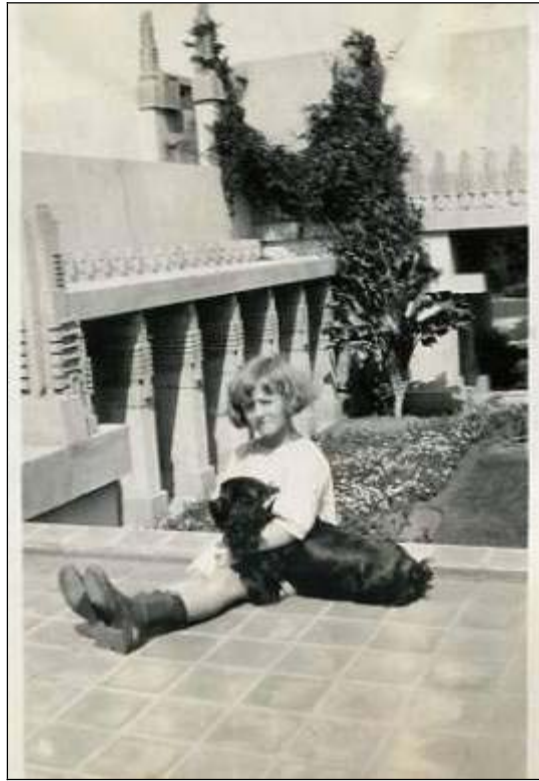
Figure 3: Barnsdall's daughter "Sugar Top" seated on the Porch Roof terrace between 1921 and 1926. Note the ceramic tile on the roof. Photo courtesy Hollyhock House Archives.

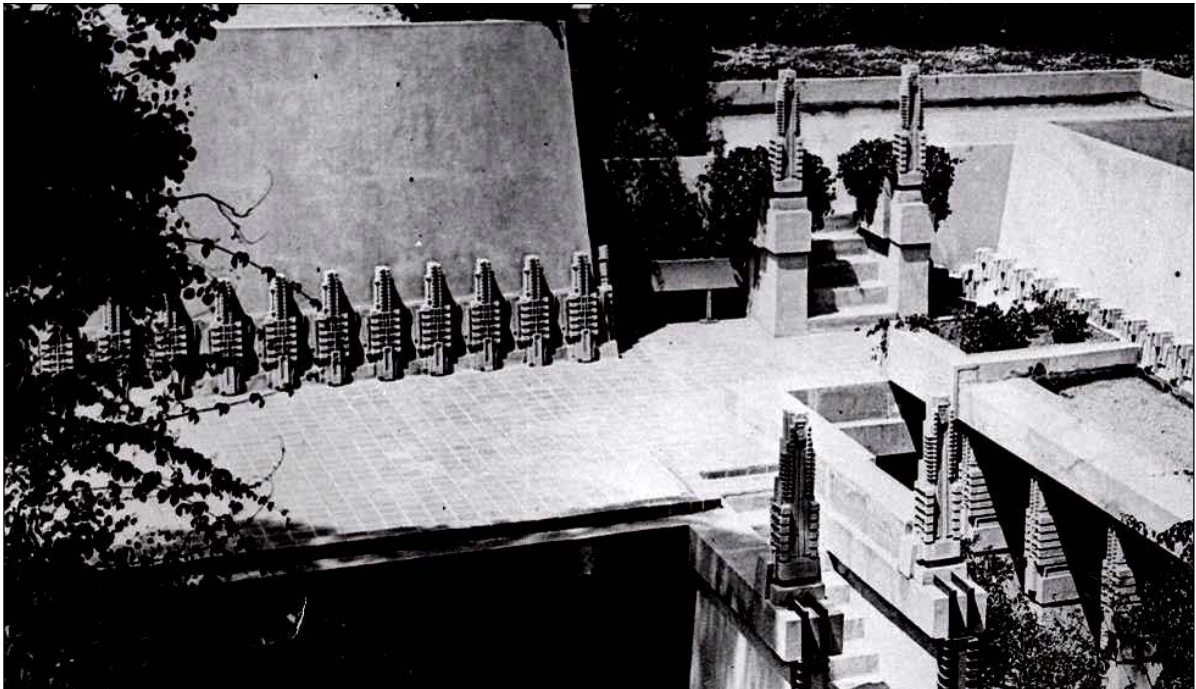
Figure 4: Close-up of an Aerial photograph of the Porch Roof, ca 1925. The tile extends all the way to the entryway roof. Photo courtesy Hollyhock House Archives.

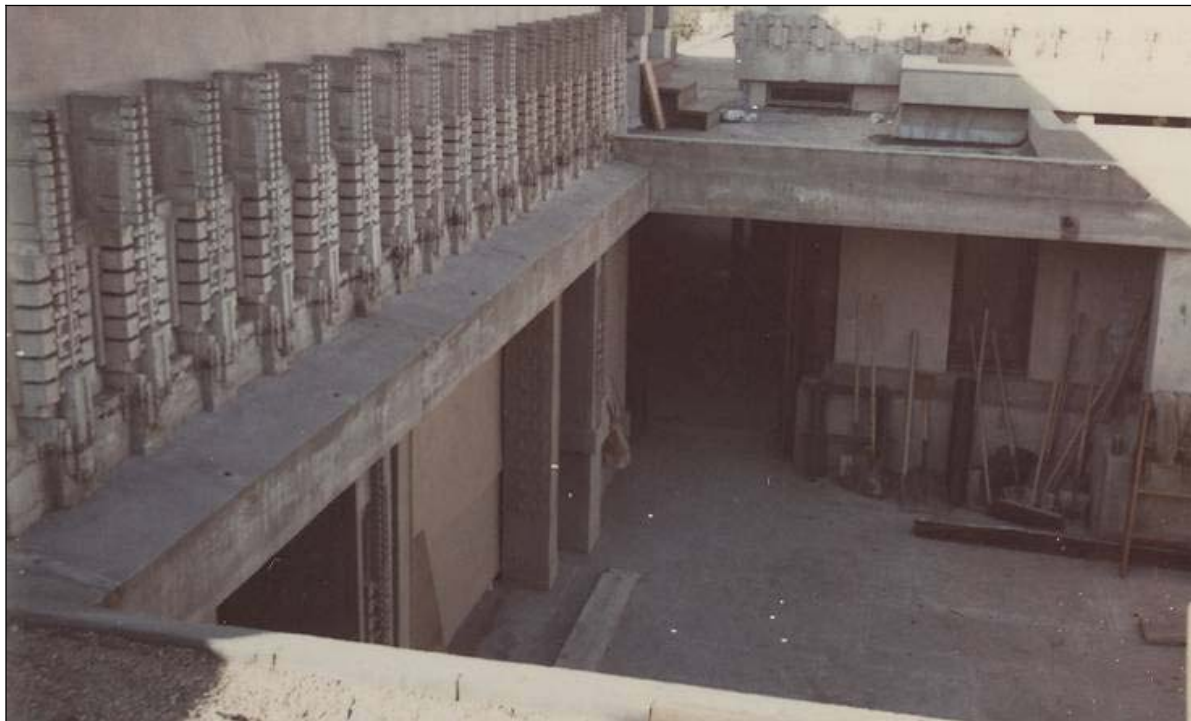
Figure 6: 1969 photograph of Porch removal. A new steel superstructure replaced the original porch in 1970. Photo Courtesy Hollyhock House archives.

In Phase I, the Porch Roof surface (including tile) was supposed to be removed to the underlying structure and replaced. However, this did not happen and is being addressed as part of Phase III repairs. According to the documentation carried out during the repairs, the flashing between the porch roof and the living room was removed and replaced.

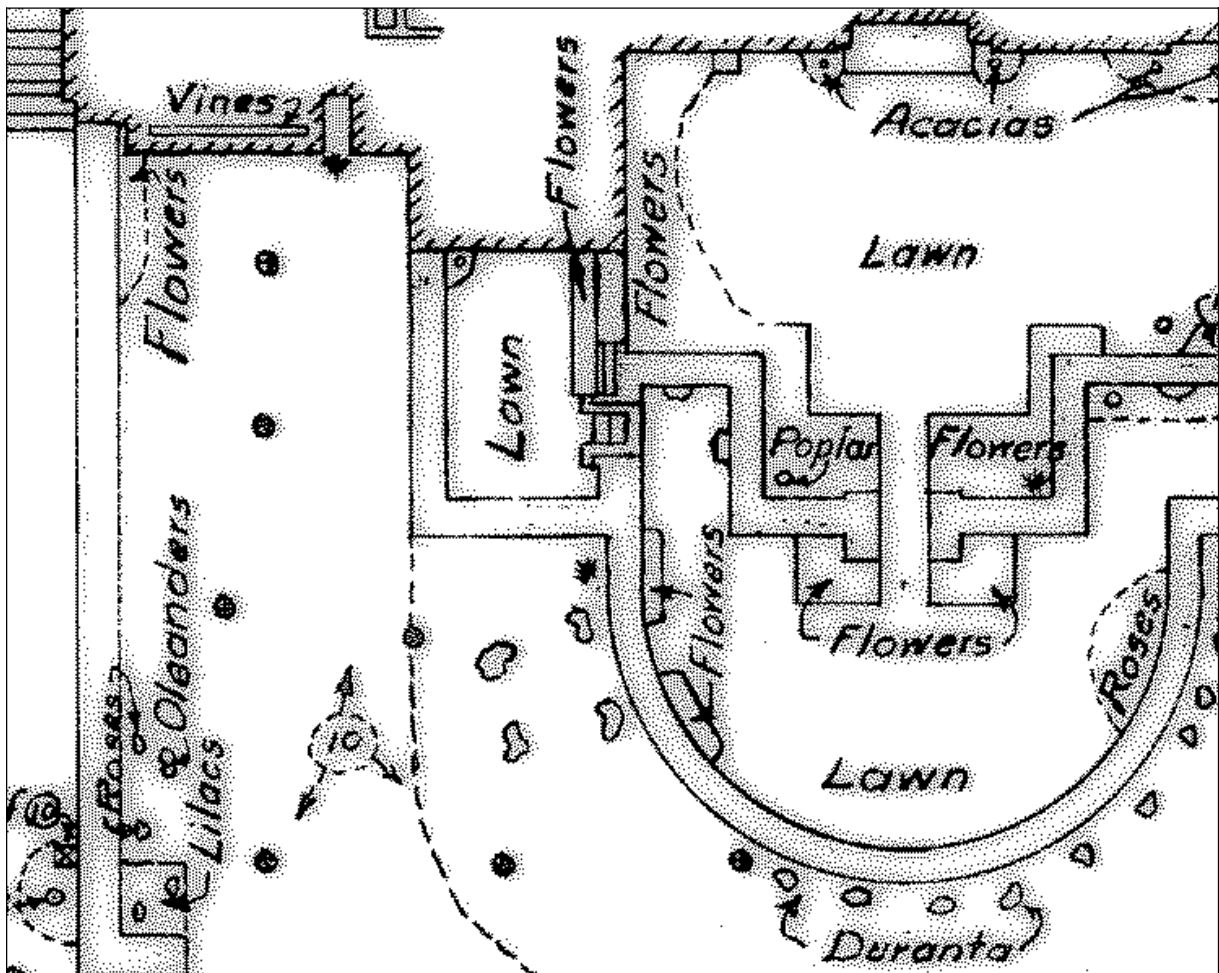
The Outer Terrace Wall and Mature Pine Tree. This area refers to portions of the Outer Terrace wall and the southern wall of the Conservatory Garden where they join. The original plans called for an enclosed garden outside the Conservatory entrance, joined to a semicircular Outer Terrace and the original Guest Rooms Terrace by a flagstone path. According to early aerial photographs and a 1927 site plan (Figure 7), the walk was never constructed, but the areas were joined by openings in the walls. This site plan also shows surrounding plantings, including a pine tree in the corner where the south wall of the Conservatory Garden and Outer Terrace join. This landscape detail corresponds to an existing mature pine tree that is causing structural damage to the garden walls.

Figure 7: Close up of a 1927 site plan depicting existing plantings. The asterisk mark in the corner where the garden wall and outer terrace join denotes a pine tree. Courtesy Hollyhock House archives.
