Conservation Report

PROJECT TITLE: Conservation Assessment of Interior Decorative Painted Features of Los Angeles City Hall

SUBJECT: Final Report

DATE: 6/6/2010

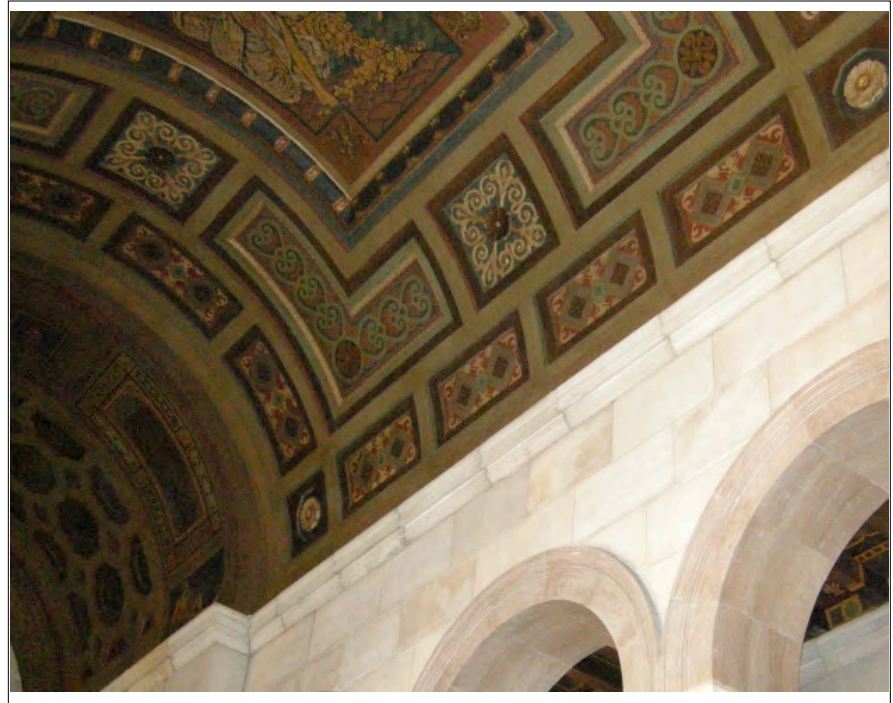
Overall Assessment	Generally good overall condition, with minor flake losses in paint, local staining, soiling.
Condition History / Previous Restoration	No reported retouching or repairs.
Structural Condition	Second panel from south end of barrel vault, peeling. Recessed coffers, south side of far south canvas, mounting peeling off.
Surface Condition	Barrel vault, south east point of panel (in corner), gold leaf thinning.

- Readhere with an appropriate adhesive system. A bulked, high-tack, neutral pH adhesive system that is capable of gap filling and retaining flexibility/resiliency may be appropriate. It should also be resistant to atmospheric moisture and biological attack. One option may be Lascaux acrylic adhesive, a dispersion of a thermoplastic acrylic polymer based on methyl methacrylate and butyl acrylate. The two types 360 HV and 498 HV are thickened with acrylic butylester. All types have a pH 8 - 9 and are biocide stabilized.

- Establish a maintenance log, noting the conditions and locations of retouchings. Supplement with digital photographs.
- A conservator should be consulted if flaking, loss, efflorescence, etc. occurs. The conservator can coordinate work that may be done as appropriate by decorative paint contractor.

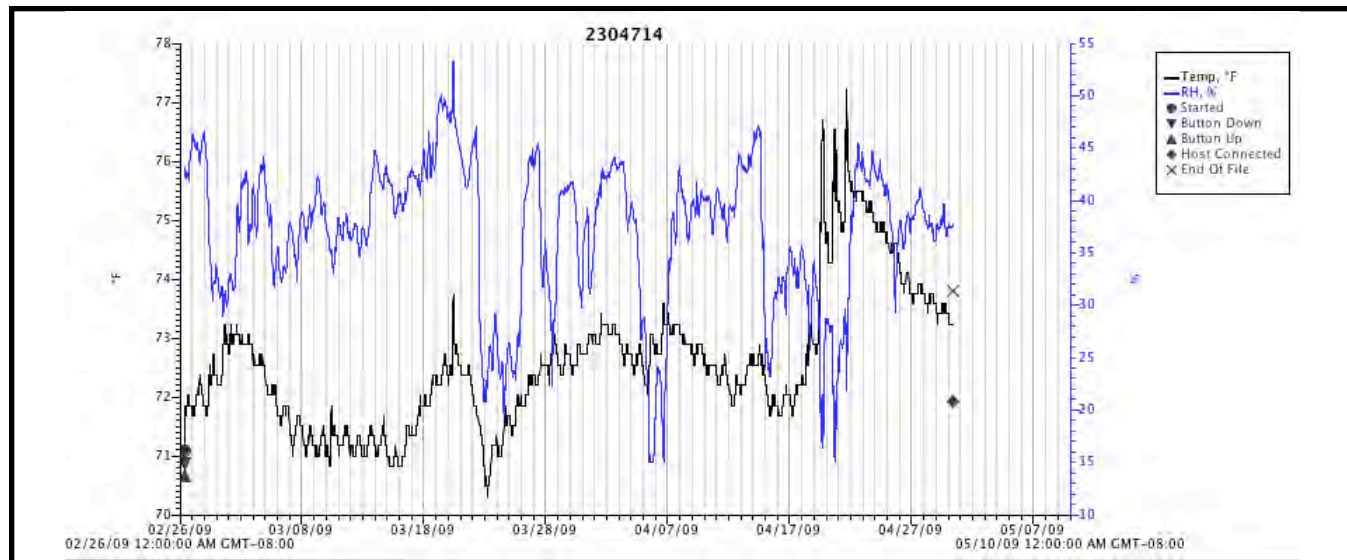
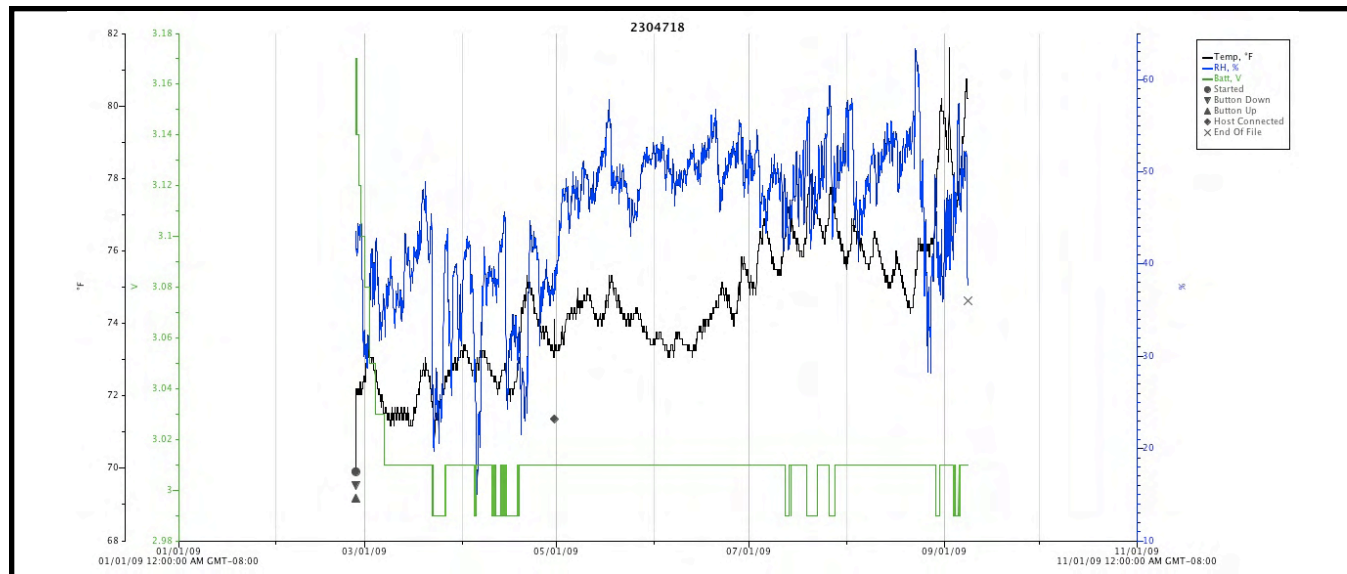
**Environmental Monitoring
Data Graphs**

Temperature range of 70 to 82 throughout the year. Diurnal fluctuations are present but not generally more than a few degrees. RH ranged from 15% to 64.5% Seasonal trends in T and RH are notable. RH swings are mainly dramatic and sudden drops, presumably due to Santana Wind conditions.

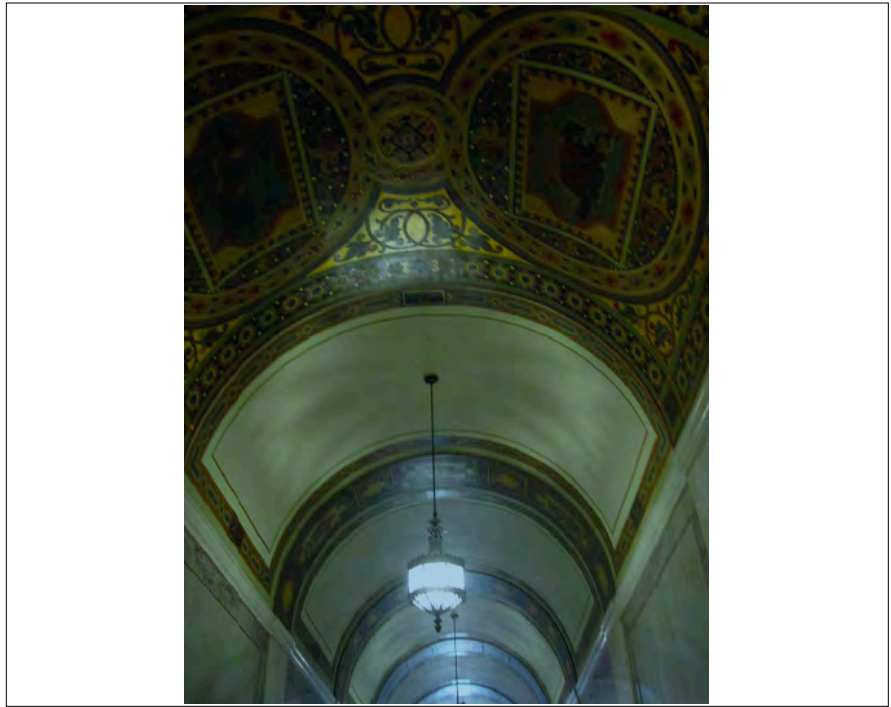
Overall Assessment	While the painted surfaces are largely intact, there has been some damage related to failure of marouflage adhesion, and a history of past repairs.
Condition History / Previous Restoration	Readhered areas of failed marouflage on vault ribs, with translucent, fluid adhesive emulsion; preliminary microchemical testing indicates PVA (iodine potassium iodide test, mixed results). Older adhesive is crystalline, powdering, golden to yellow, translucent. Slight swelling in toluene. Possibly animal glue. Presumably original, but possibly an earlier attempt at readhesion.
Structural Condition	Good structural condition of substrates. Some crumbling, powdering of plaster at areas of marouflage detachment. Not clear evidence of salts.
Surface Condition	South rib panel, east end, flaking at bottom. East side, canvas pulling away from wall revealing plaster substrate. Northernmost rib, marouflaged panel, detachment and drooping at apex of barrel vault. Amber-brown discoloration originally suspected to be mildew appears to be discolored resin accretion. Local inpaint/overpaint touchups are discolored.

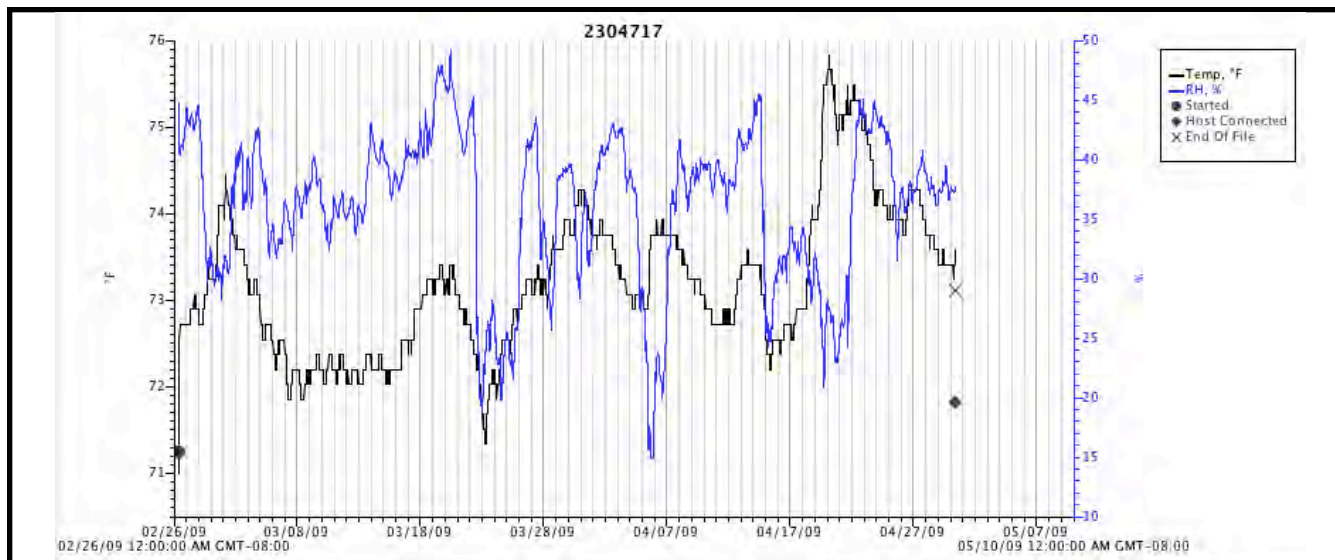
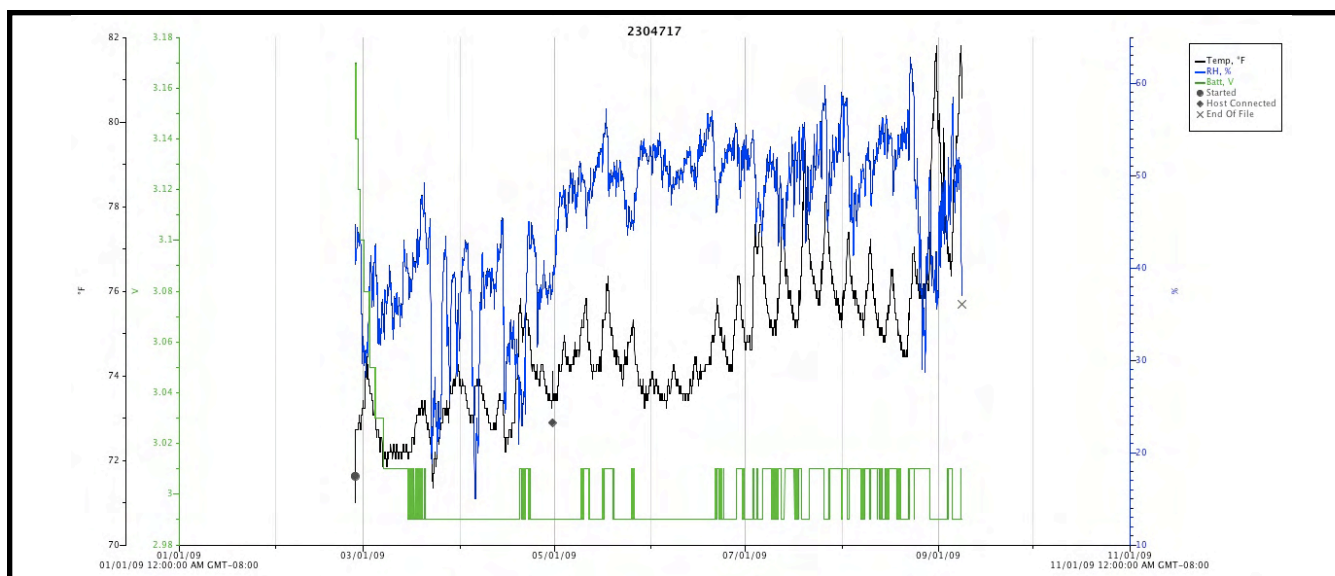
**Environmental Monitoring
Data Graphs**

Temperature range of 71 to 81 degrees F throughout the year. Diurnal fluctuations are present but not generally more than a few degrees. RH ranged from 15% to 64.5% Seasonal trends in T and RH are notable. RH swings are mainly dramatic and sudden drops, presumably due to Santana Wind conditions. However, it is significant to note that the hallway where the most failure of canvas and paint adhesion has occurred has an environment closely similar to other, more stable areas on this floor.

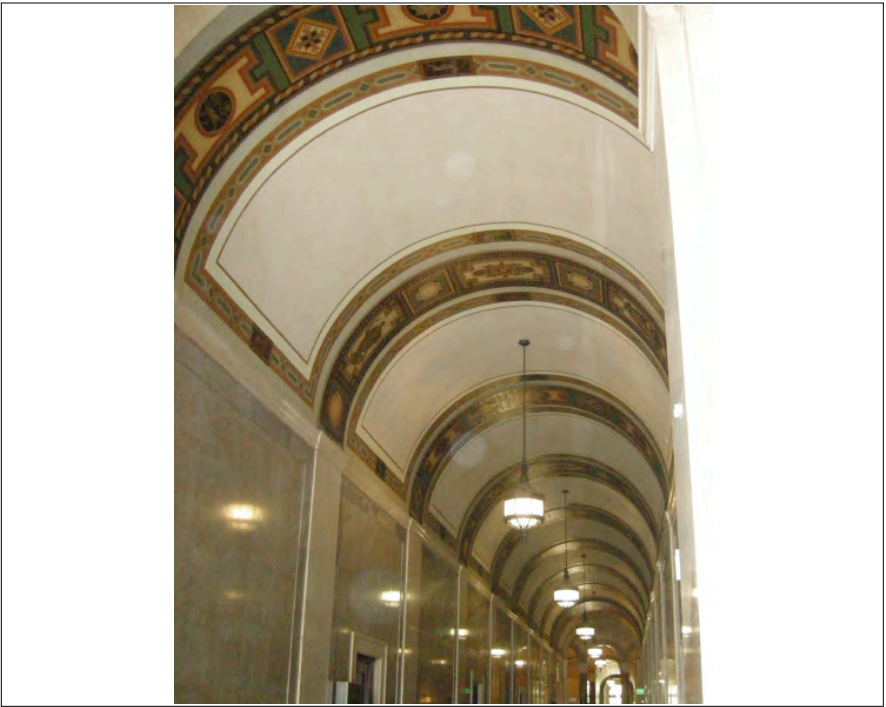
Overall Assessment	While the painted surfaces are largely intact, there has been some damage related to failure of marouflage adhesion, and a history of past repairs.
Condition History / Previous Restoration	Readhered areas of failed marouflage on vault ribs, with translucent, fluid adhesive emulsion; preliminary microchemical testing indicates PVA (iodine potassium iodide test, mixed results). Older adhesive is crystalline, powdering, golden to yellow, translucent. Slight swelling in toluene. Possibly animal glue. Presumably original, but possibly an earlier attempt at readhesion. No moisture infiltration has been noted since the seismic renovations. Some may have occurred prior to that.
Structural Condition	Good structural condition of substrates. Some crumbling, powdering of plaster at areas of marouflage detachment. Not clear evidence of salts.
Surface Condition	Bottom of both east and west have white chalky residue, related to above. First marouflaged rib at north end of hallway, at both east side and west side, exhibit tears in canvas, previously mended but adhesion failure has reintroduced stress and more tearing. Near the 4th canvas panel from south end of hall, there is local paint loss revealing plaster substrate; possible water damage along edge of marble cornice (where marble meets canvas) on east side. Local amber-brown staining, accretions on marouflaged roundels

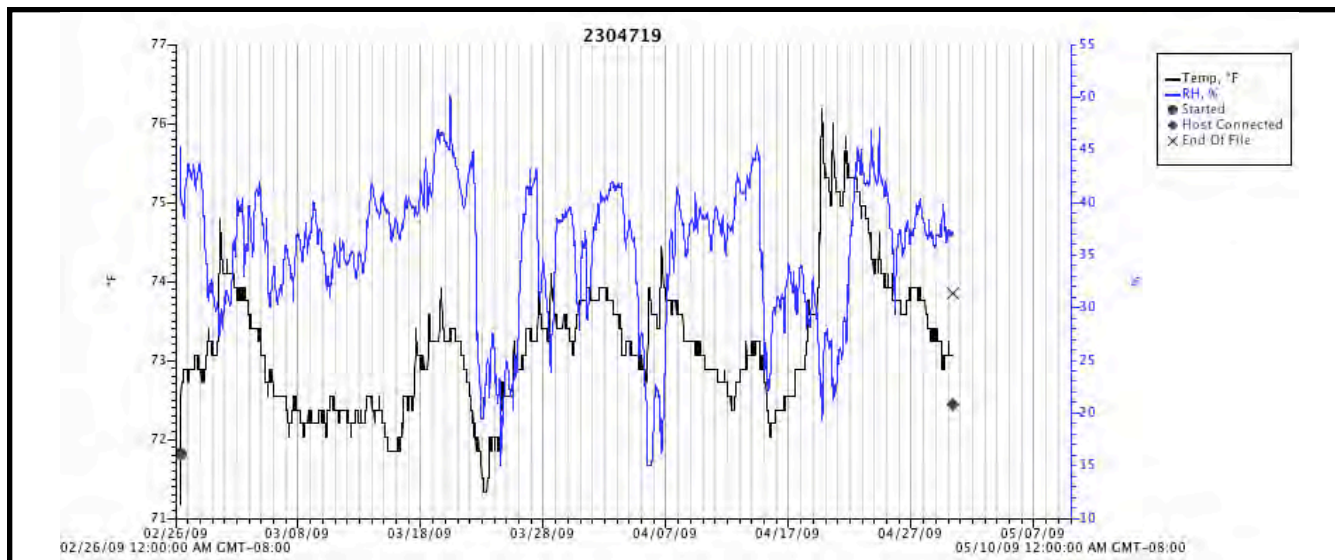
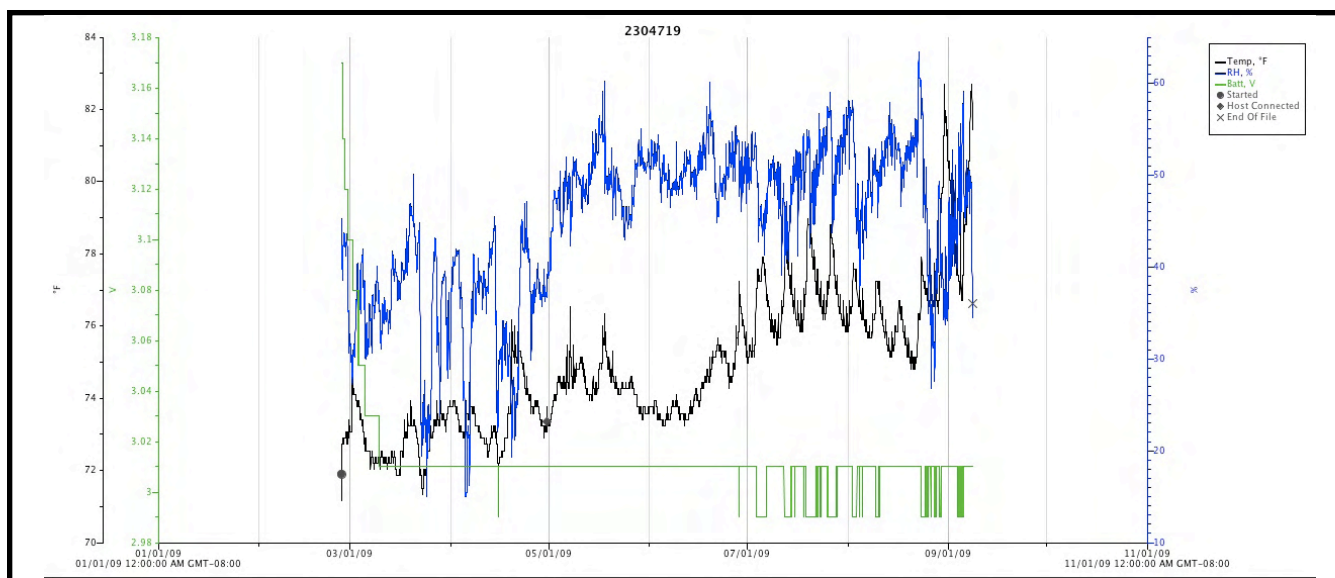
**Environmental Monitoring
Data Graphs**

Temperature range of 71 to 82.6 degrees F throughout the year. Diurnal fluctuations are present but not generally more than a few degrees. RH ranged from 15% to 63.4% Seasonal trends in T and RH are notable. RH swings are mainly dramatic and sudden drops, presumably due to Santana Wind conditions. However, it is significant to note that the hallway where the most failure of canvas and paint adhesion has occurred has an environment closely similar to other, more stable areas on this floor.
