**Environmental Description
Summary**

Main Feature Name Vaulted ceiling, walls, window surrounds in antechamber

Location Board of Public Works

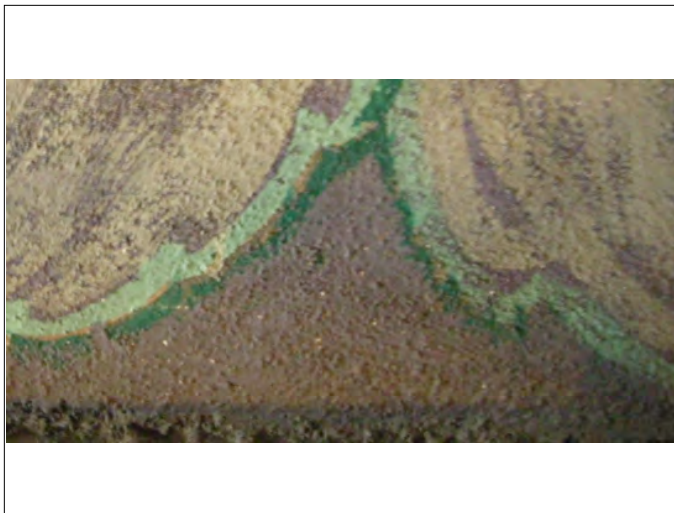
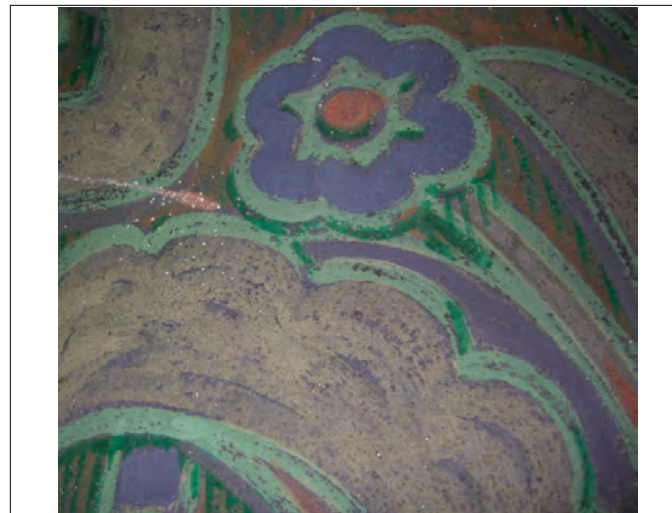
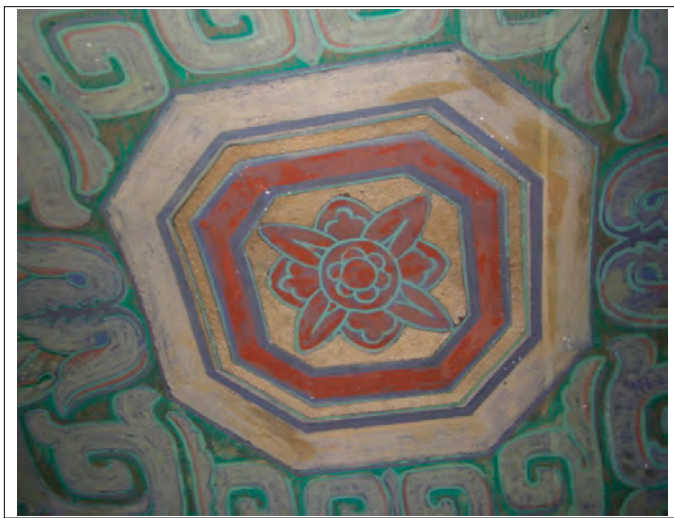
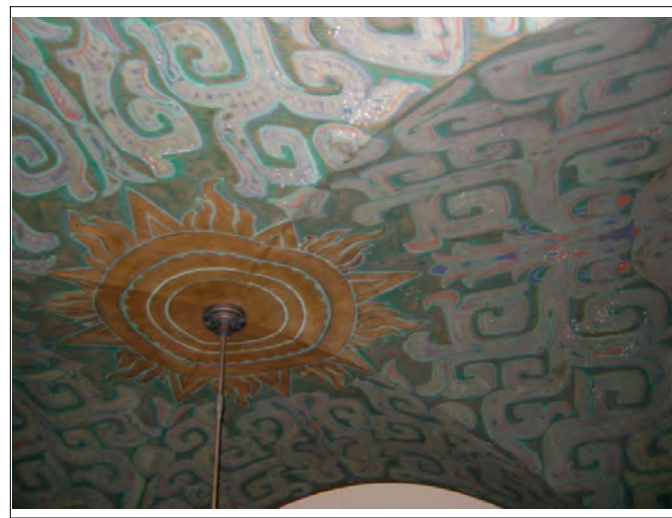
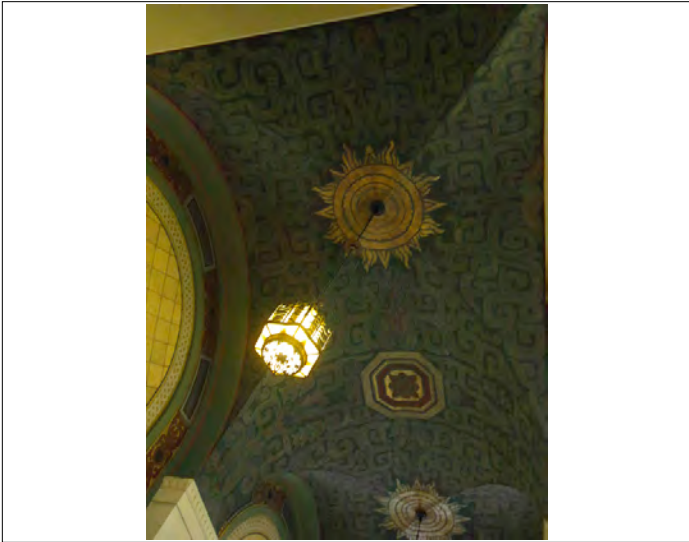
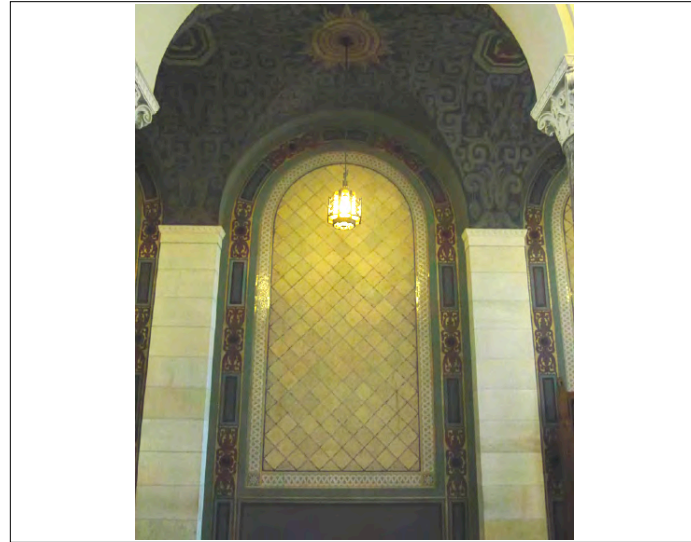
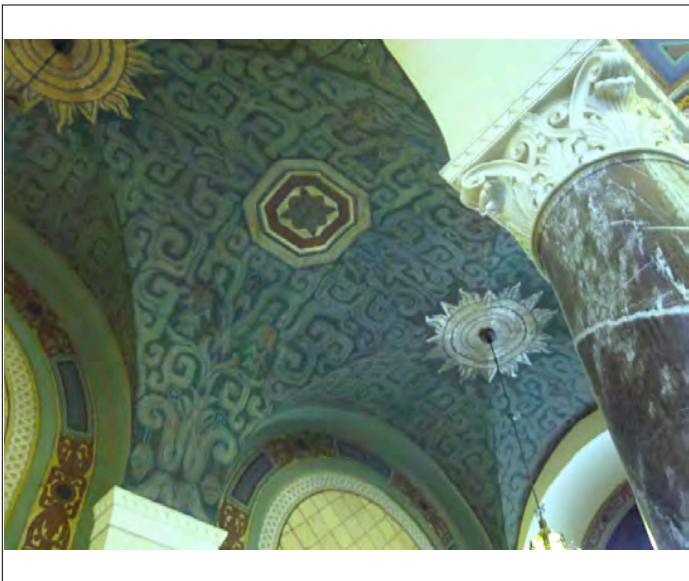
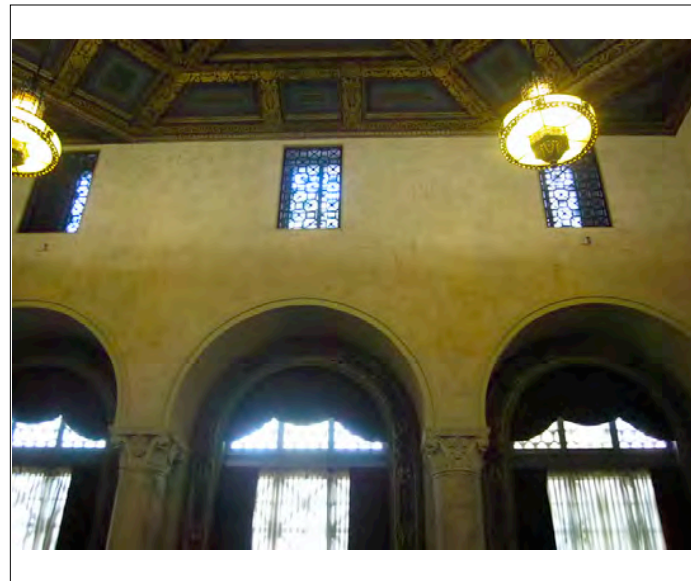
Overall Assessment	Overall good condition, with some minor paint loss, local staining. Retouched.
Condition History / Previous Restoration	Past history of minor touch-ups with oil paint over unfilled flake losses. Grime on walls from human contact, overpainted, scrubbed, etc. Tatyana Thompson conducted solubility and cleaning tests in 1999.
Structural Condition	Structural cracks in window surrounds, reported in 1999.
Surface Condition	Minor paint loss, local dark staining, e.g. at apex of vaults, grime, related abrasions from public contact on back wall, proximity of furniture, etc. Possible re-varnishing is exacerbating paint loss. Pinhole losses, presumably from lost sand grains.

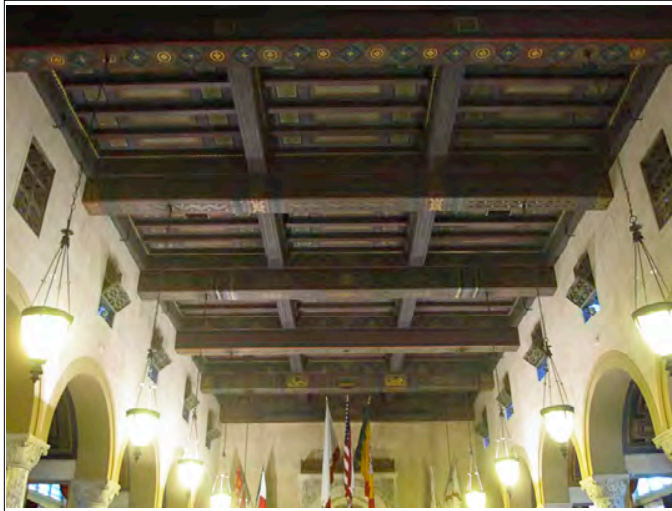
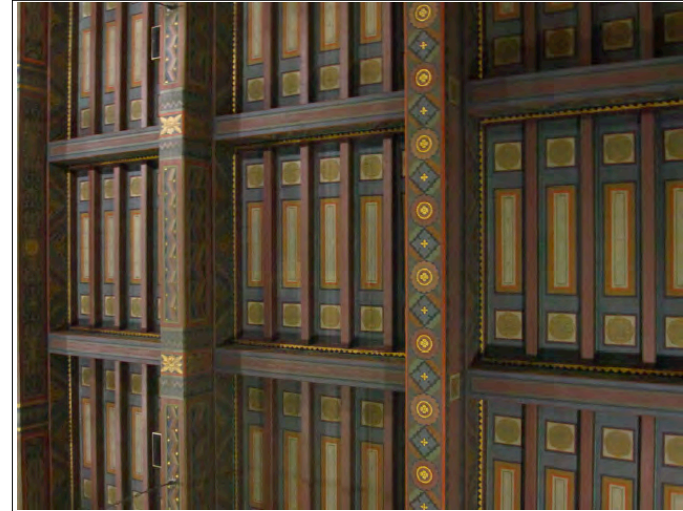
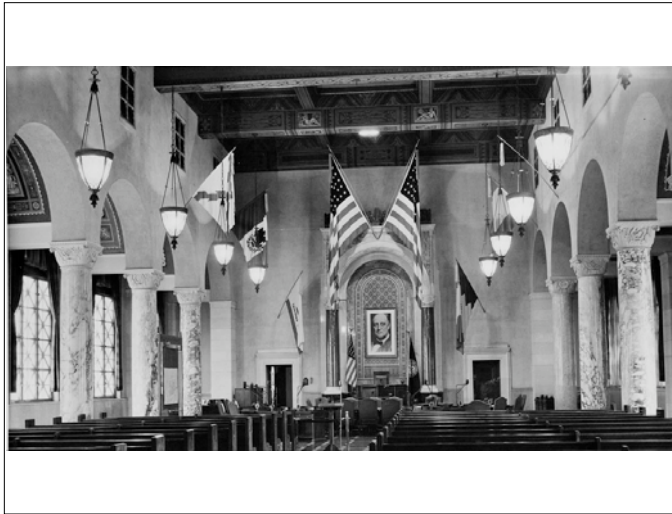
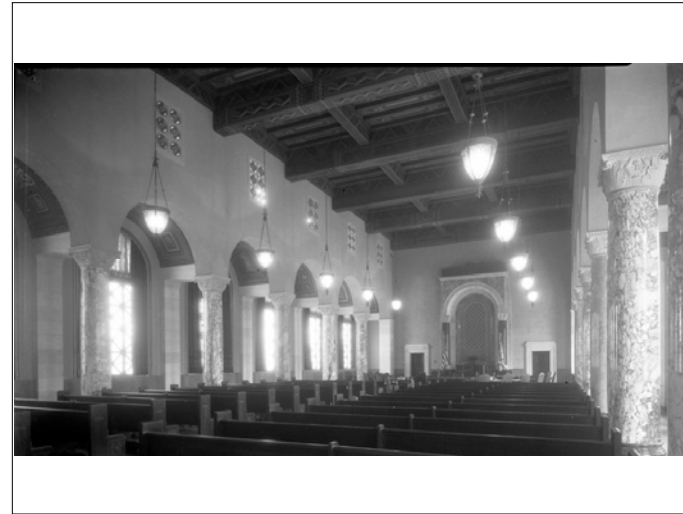
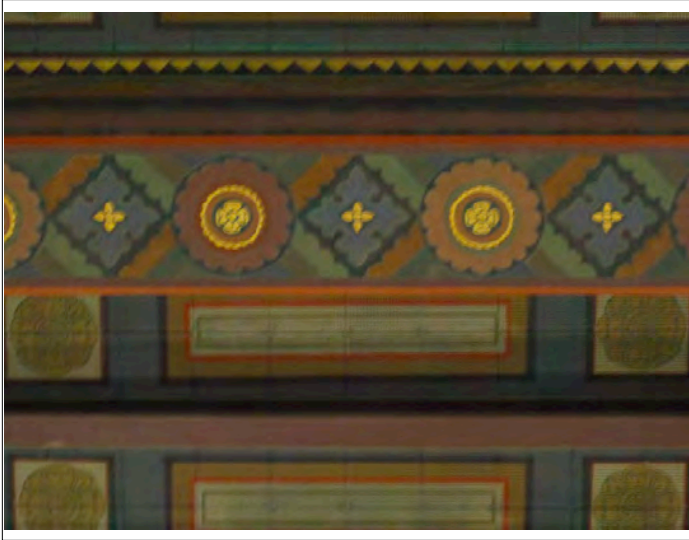
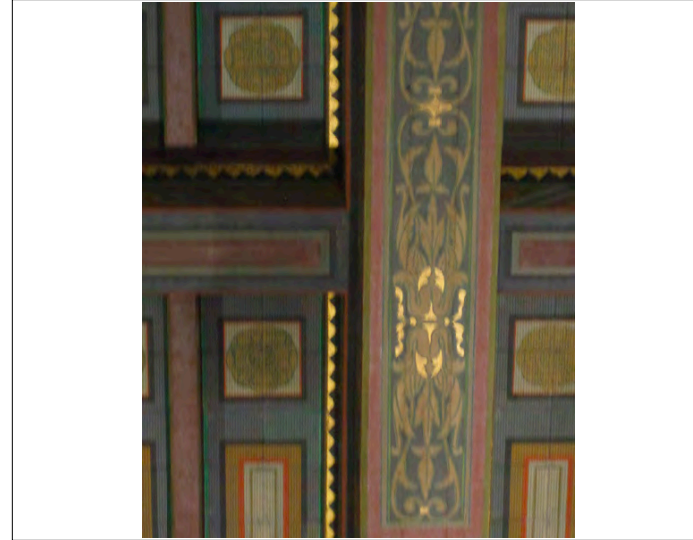
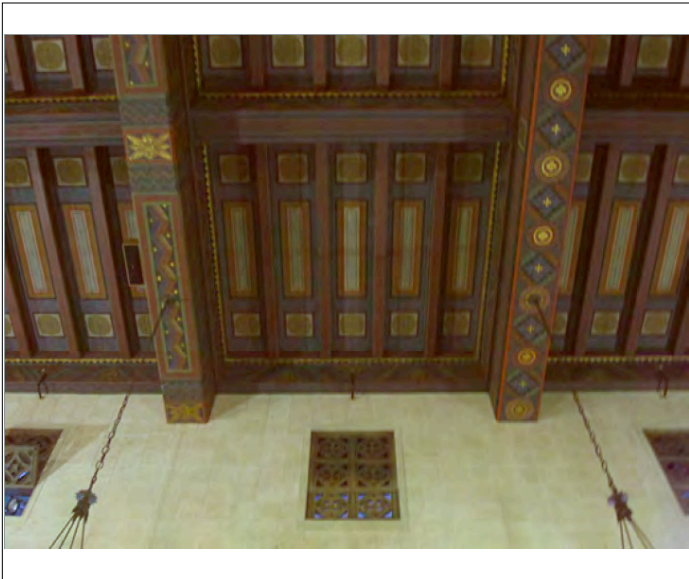
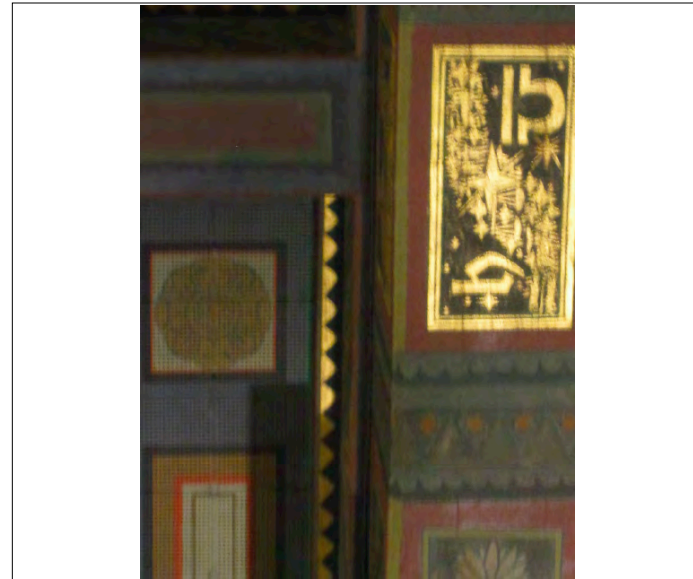
Binocular survey indicates the ceiling is in good overall condition, but heavily soiled with dark grime. Any past inpainting or other touch-ups are not apparent. Paint on Celotex ceiling tiles are highly sensitive to water, very friable, especially the blue-green color, according to Thompson report (1999). Blind arches on back wall are stable but soiled. Some sensitivity to water found by Thompson on all but gold, beige and black banding.

Good structural condition, based on remote observation. Internal structure, reinforcements should be confirmed and evaluated in the future. Window opening marouflage panels appear to be well-adhered.

Some general darkening has occurred due to soiling and oxidation of coatings, etc. Abrasion and grime on lower areas within contact of public. Water soluble paint is friable.

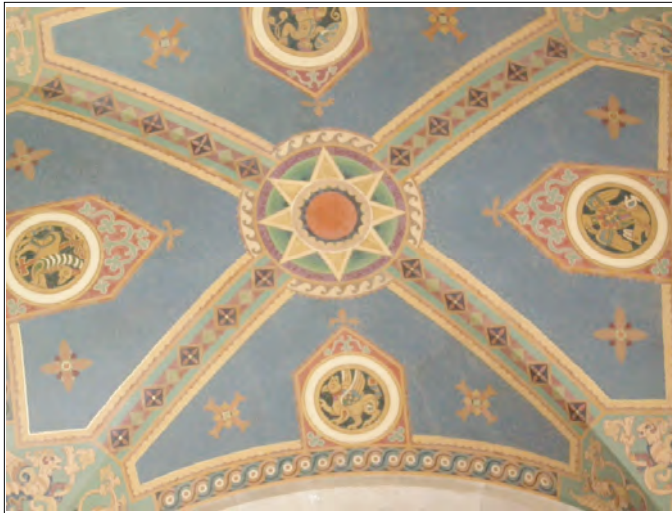
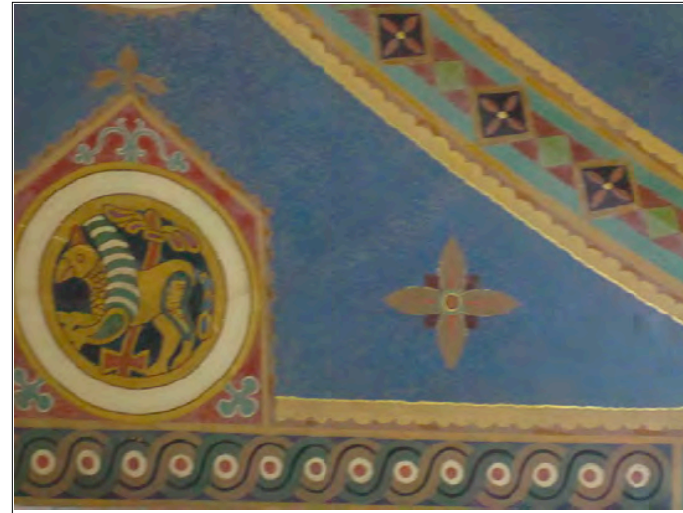
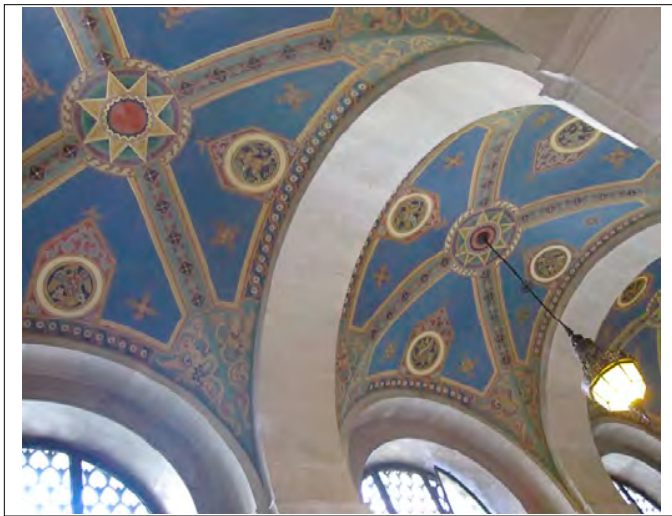
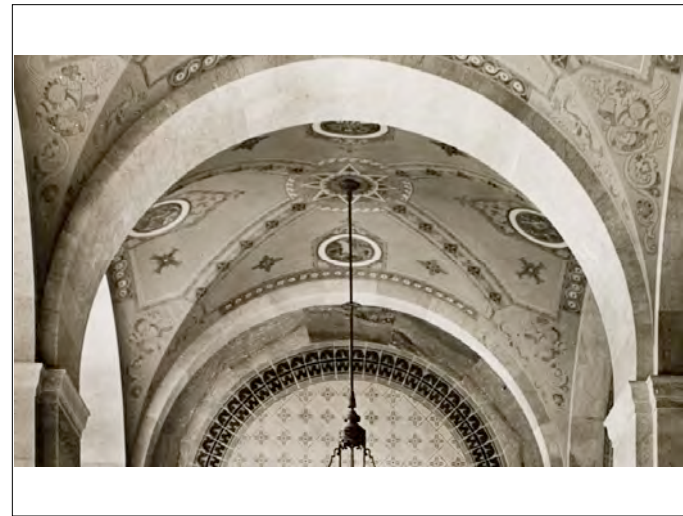
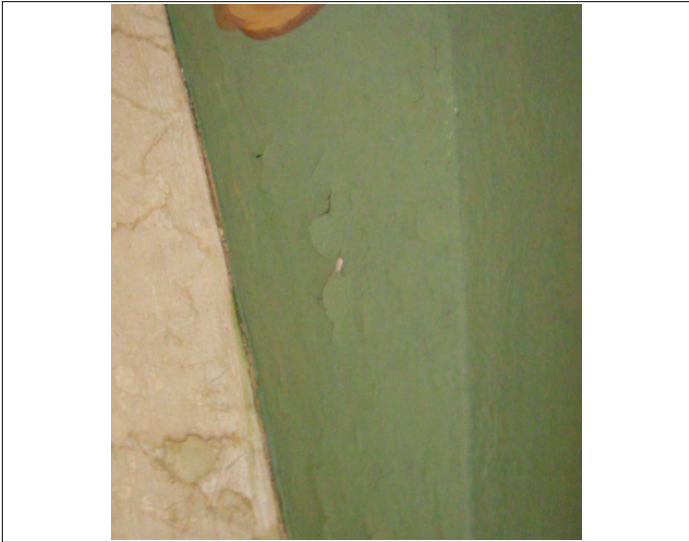
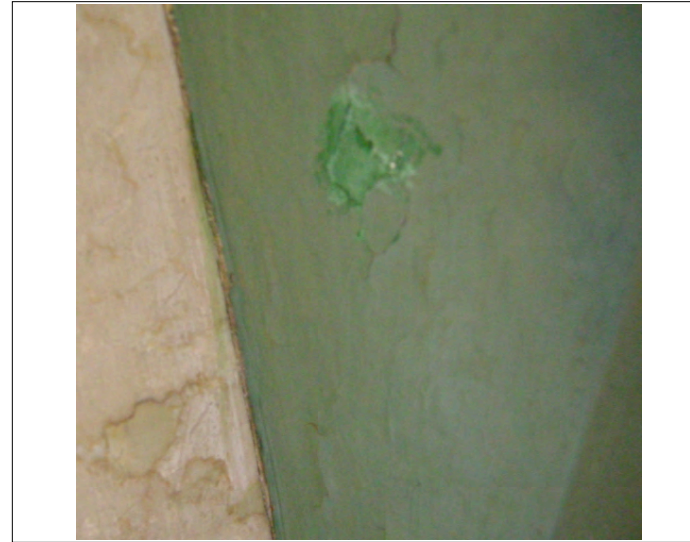
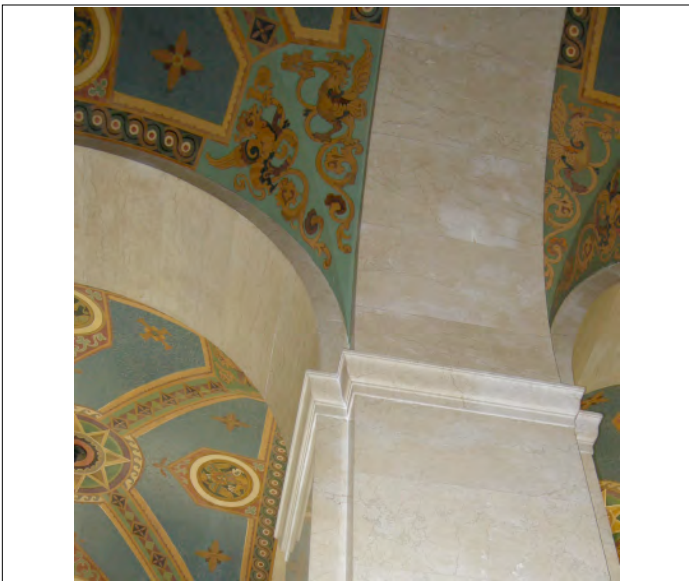
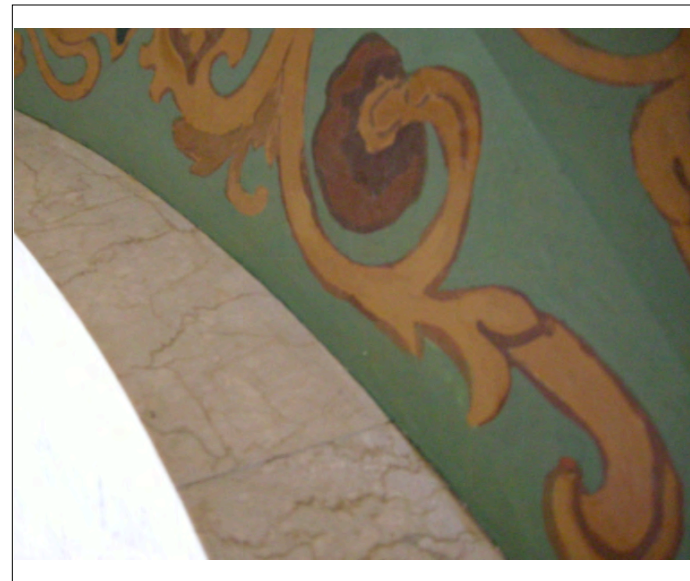
Overall Assessment	Generally good condition overall, some active flaking at lower corners of vault springs.
Condition History / Previous Restoration	<p>Retouching, various campaigns. Mismatched green touch-up paint applied over loss without infilling.</p> <p>Comparison with archival photo, ca. 1928, shows the design and tonal range of the fields, etc. is relatively intact today. (See photo from USC Digital Library archive, ID# examiner-m13189 (part of Los Angeles Examiner Prints Collection, late 1920's - 1961).</p>
Structural Condition	Good apparent structural condition. Marouflage elements appear well adhered.
Surface Condition	Star over stairs in center vault, paint peeling (speck) revealing plaster substrate, SW.

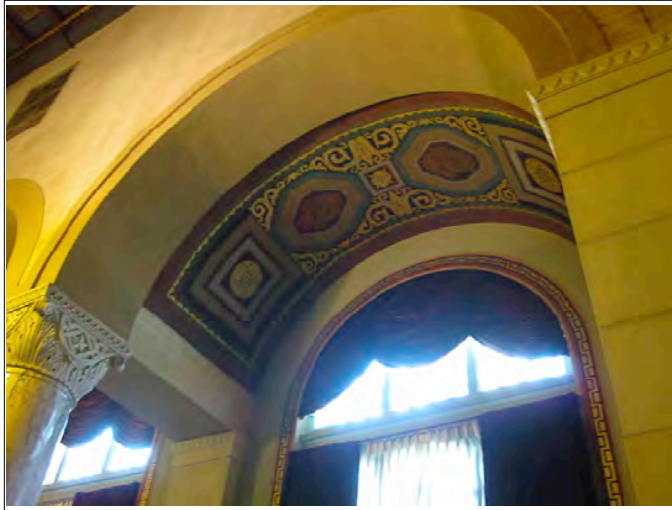
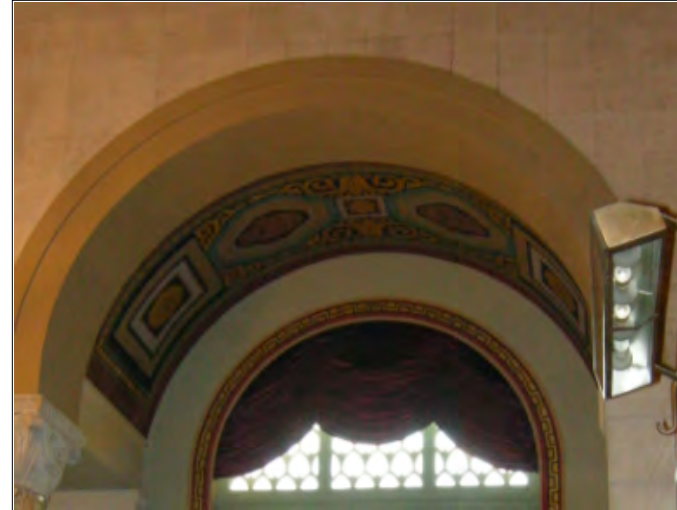
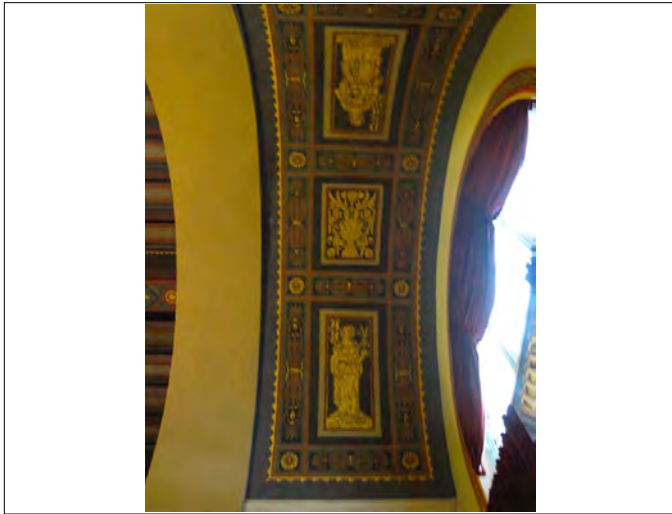
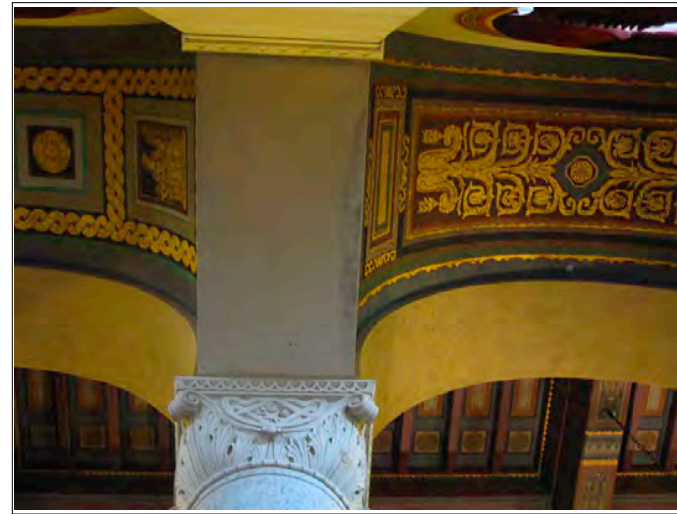
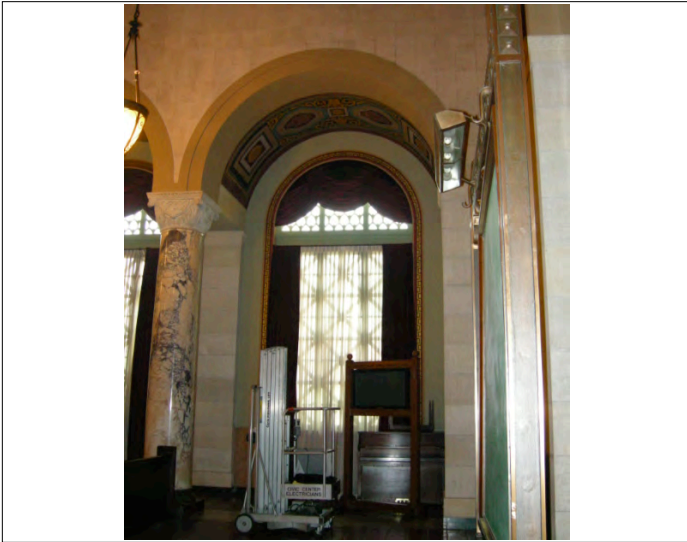
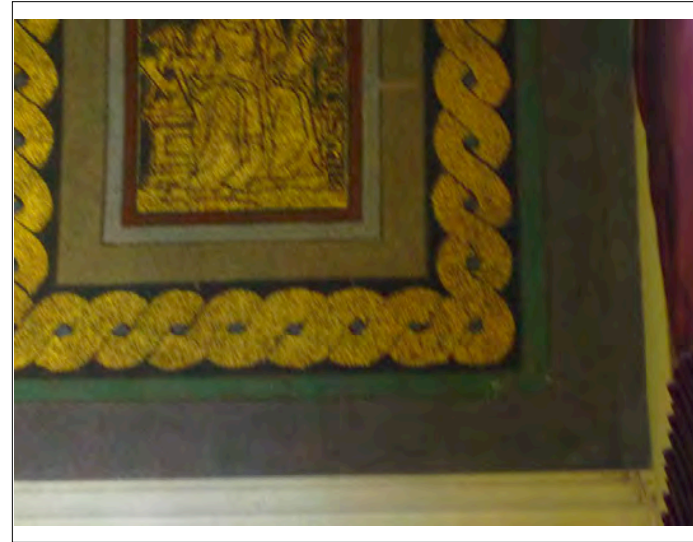
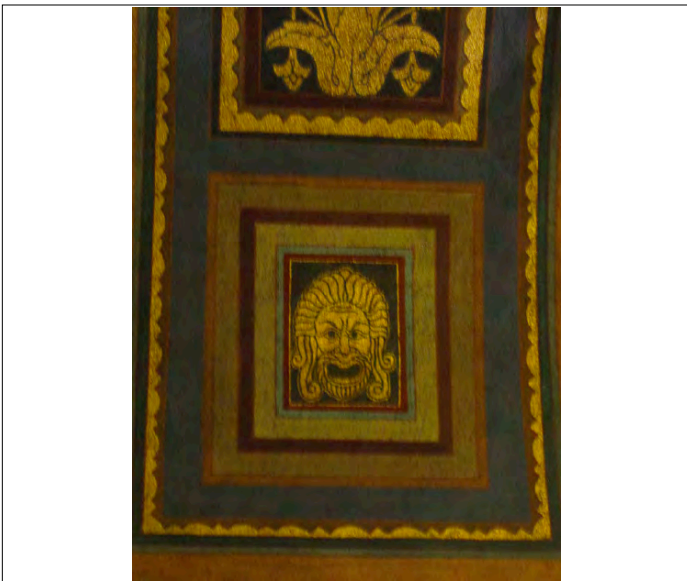
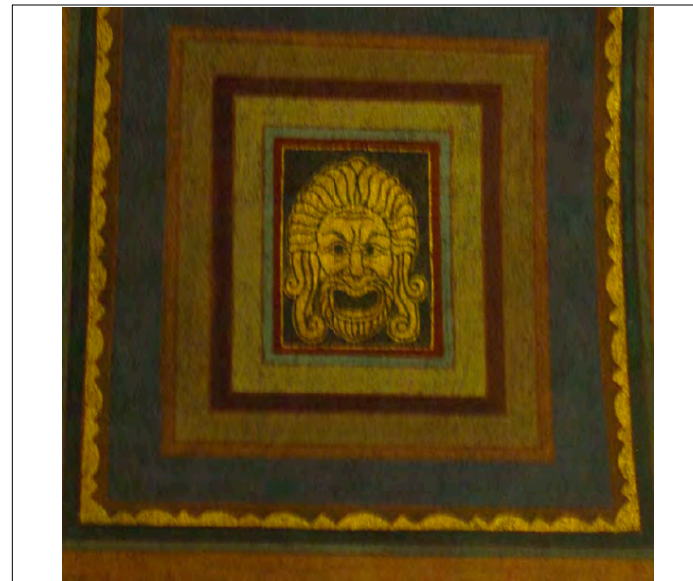
Overall Assessment	Dark staining from moisture damage, cracks in plaster, friable paint overall, except gold areas, reported by Thompson. Many small pinhole losses, presumably due to loss of sand grains, described in the Thompson report.
Condition History / Previous Restoration	<p>Local areas of inpainting scattered throughout murals. Tatyana Thompson conducted solubility and cleaning tests in 1999. Murals may have been treated since then, as surfaces no longer seem dry and chalky; possibly coated or consolidated. Pinhole losses may have been inpainted. Stains may have been at least partially overpainted.</p> <p>Based on comparison with archival photos (USC Digital Library ID# chs-m1854, Part of Los Angeles Area Chamber of Commerce Collection, 1890-1960 USC; and ID# chs-m21101, California Historical Society Collection, 1860-1960 USC), the tonal range and contrast between background and design elements remains consistent since 1928.</p>

Structural Condition	Cracks, moisture-related damage, presumably stabilized in seismic rehabilitation project.
Surface Condition	Some general darkening has occurred due to soiling and oxidation of coatings, etc. Added consolidant or coating may be contributing to loss of adhesion of paint at ground layer.

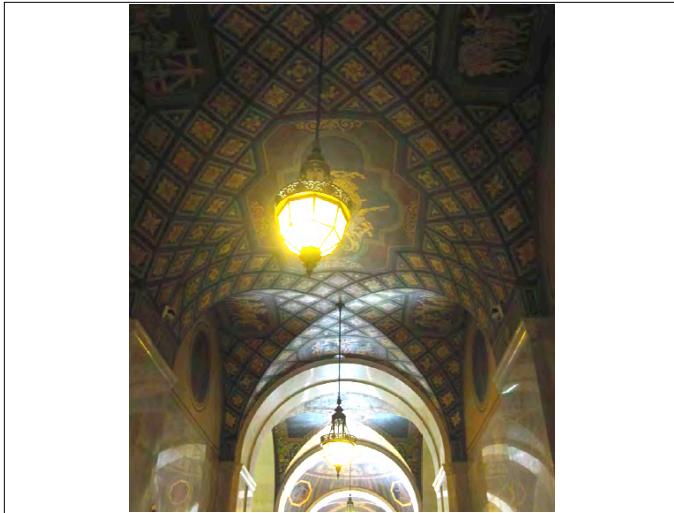
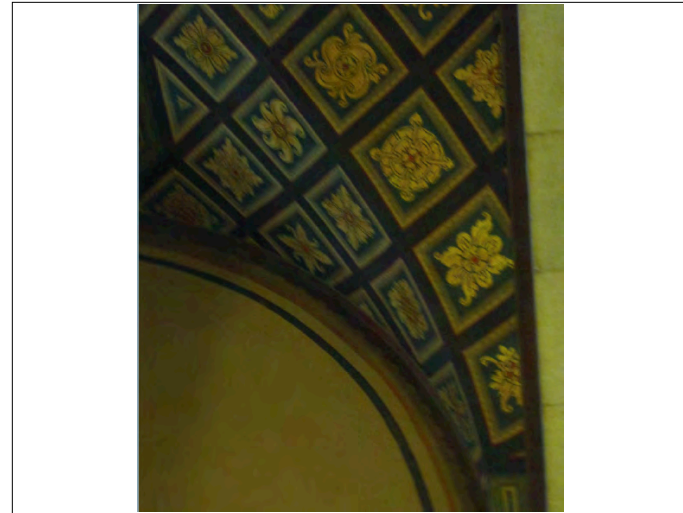
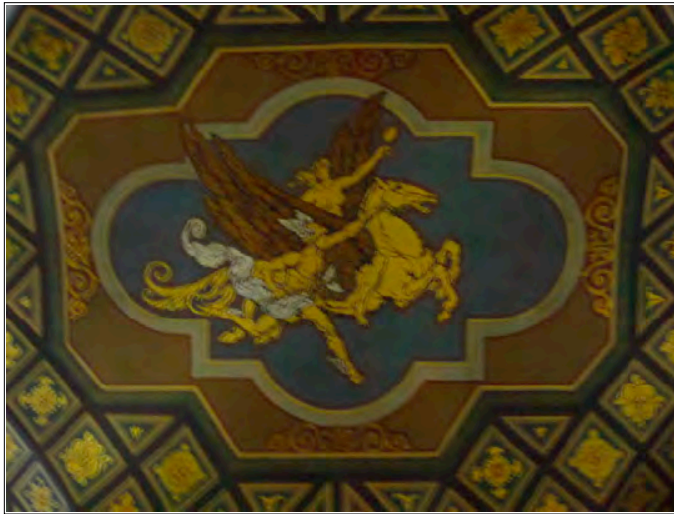
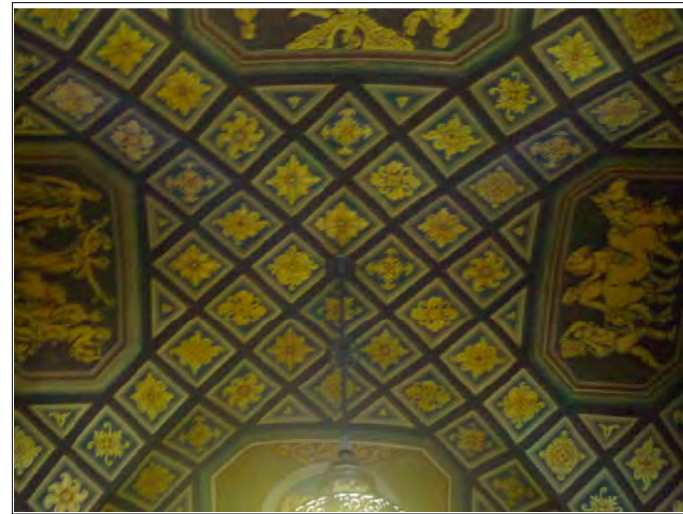
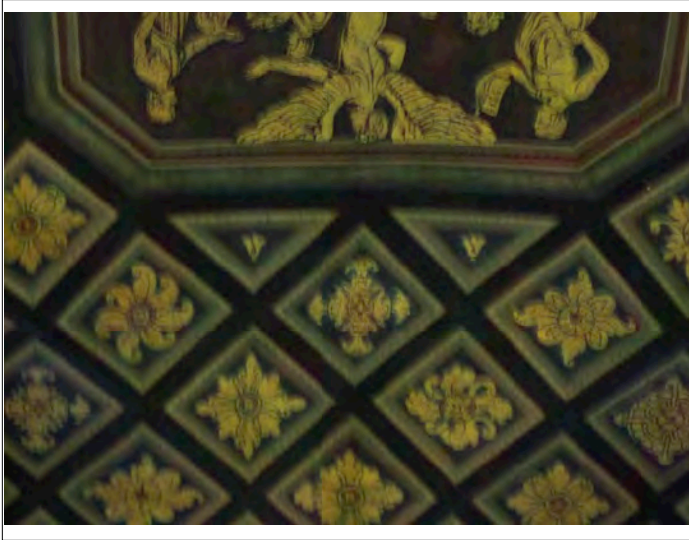
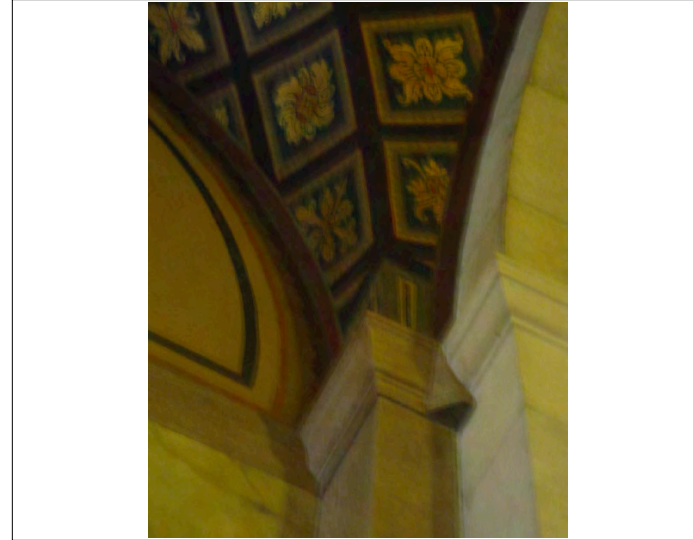
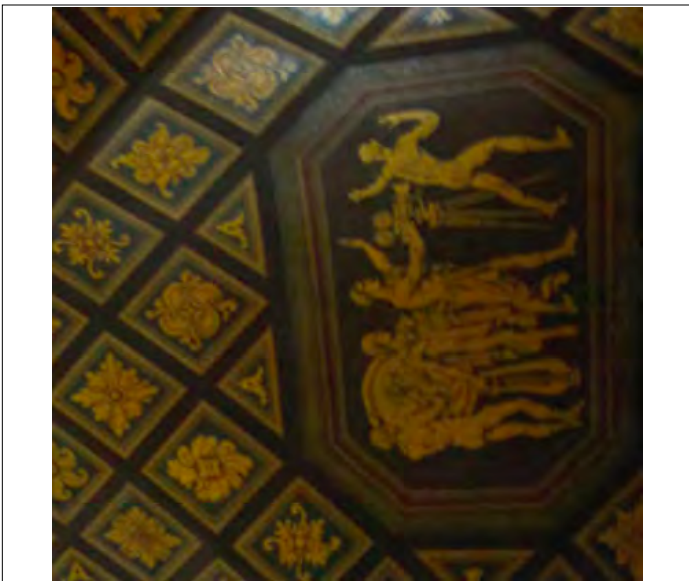
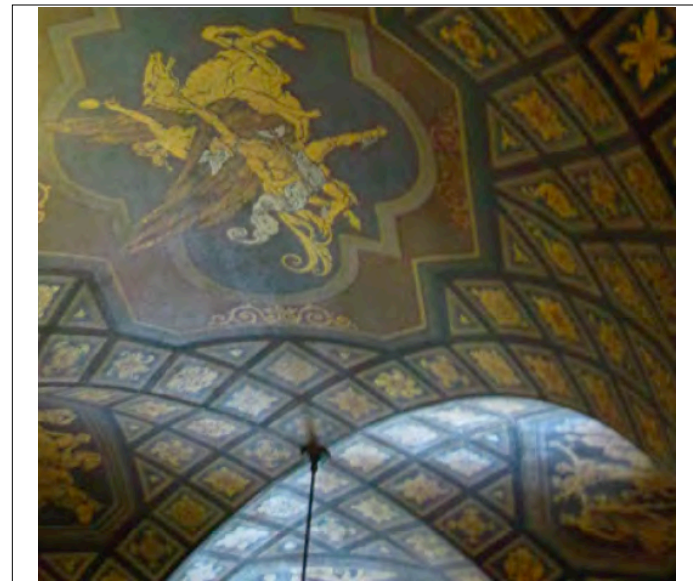
Overall Assessment Generally in good condition. Some darkening, oxidation of surface may have occurred. Generally well protected area.

Structural Condition Good, with no apparent losses, erosion of details, cracks.

Surface Condition Good, possible darkening, oxidation of glaze or other clear coat (varnish) if present.

Treatment Recommendations Superficial cleaning to remove adhered soiling and dust.
